Lower Coeur d'Alene Riverbank Stabilization Prioritization

Prepared by:
Kootenai-Shoshone Soil and Water Conservation District
7830 Meadowlark Way, Suite C-1
Coeur d'Alene, Idaho 83815
(208) 762-4939
Craig Nelson and Bob Flagor

In Cooperation with Idaho Department of Environmental Quality
Coeur d'Alene Regional Office
2110 Ironwood Parkway
Coeur d'Alene, Idaho 83815
Kristin Keith and Thomas Herron

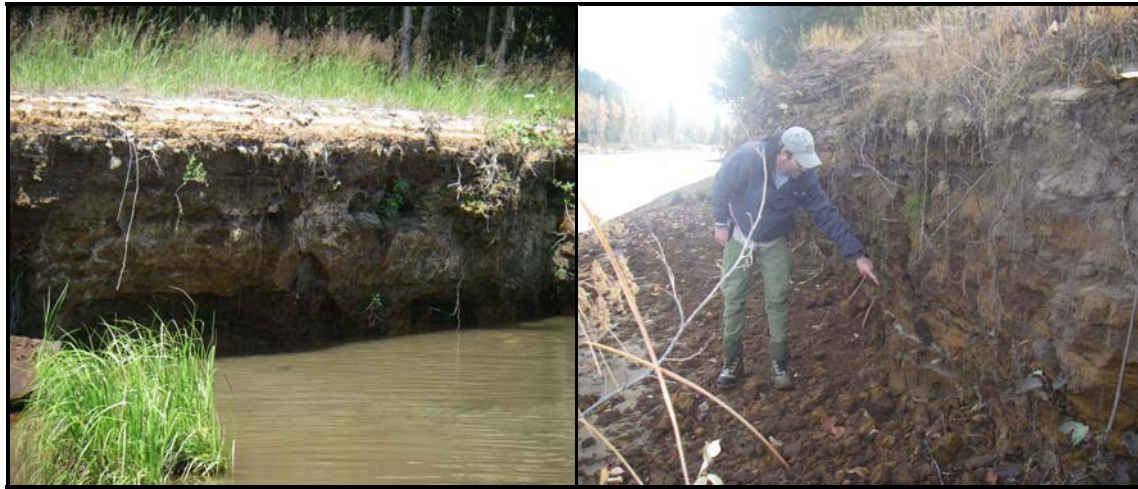
Bank Type 1

- Bank angle is typically 90 degrees.
- Root density is less than 5 percent.
- Root depth is no greater than two feet.
- Presence of mine tailings are prominent, causing typically “massive” structure of riverbank soils.
- An obvious distinction exists between tailings and pre-mining soils (when visible).

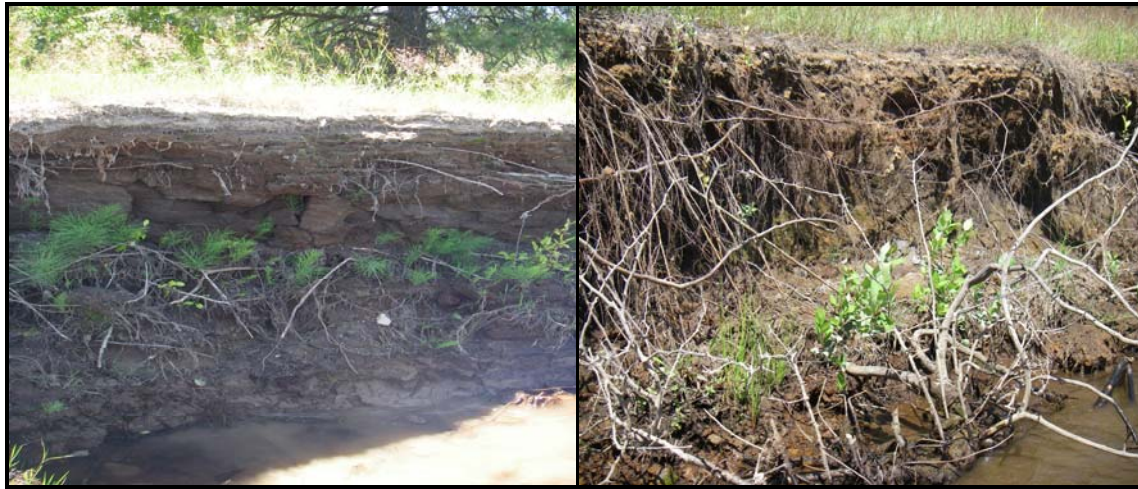
Bank Type 2

- Riverbank height is less than eight feet.
- Bank angle is greater than 90 degrees.
- Root density is 10-15 percent.
- Root depth is two to five feet.
- Presence of mine tailings are less obvious, and riverbank soils do not exhibit such a “massive” structure.

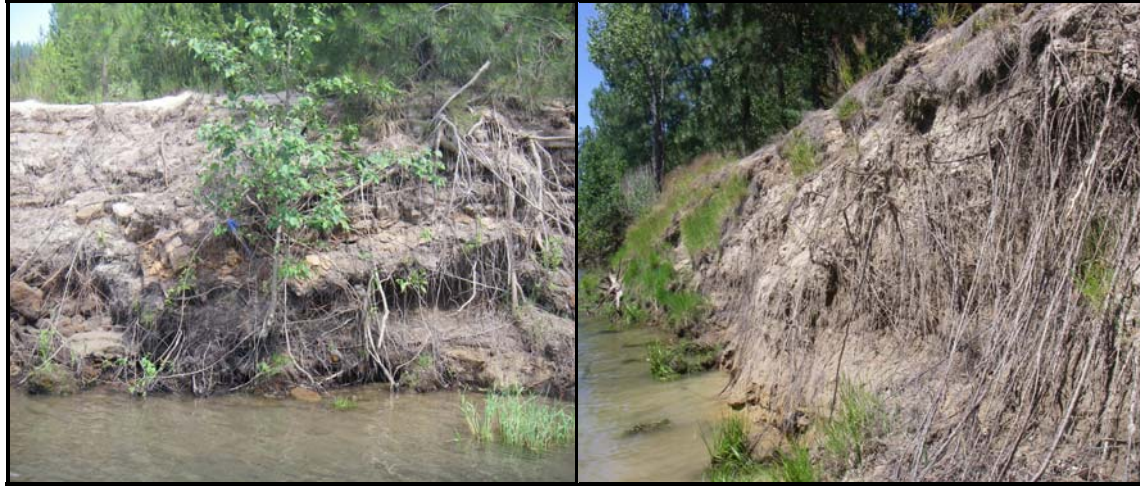
Bank Type 3

- Riverbank height is greater than eight feet.
- Bank angle is greater than 90 degrees.
- Root density is 10-15 percent.
- Root depth is two to five feet.
- Presence of mine tailings are less obvious, and riverbank soils do not exhibit such a “massive” structure.

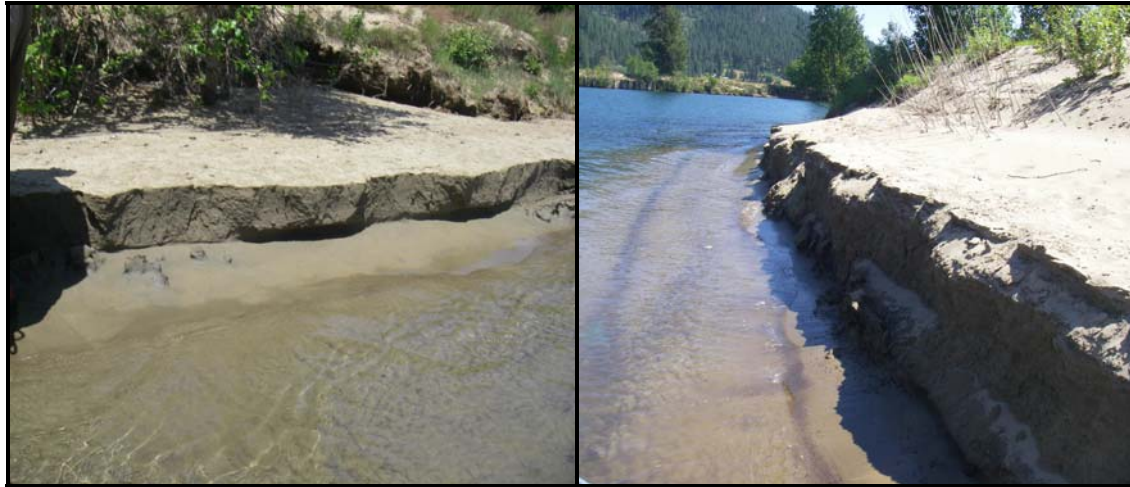
Bank Type 4

- Sandy bars are present.
- Lack of vegetation and root density exist.

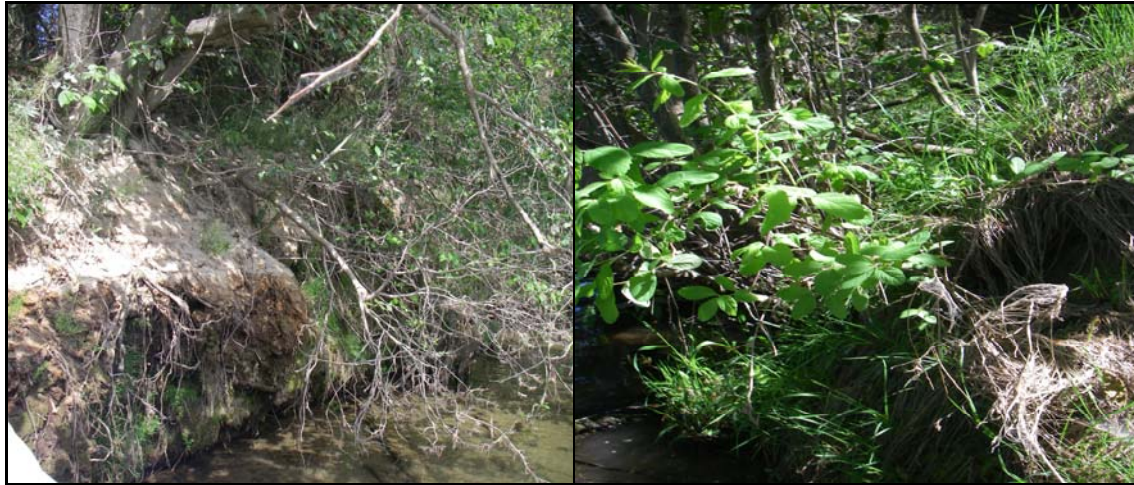
Bank Type 5

- Banks are highly vegetated with shrubs.
- Root density is greater than 30 percent.
- Root depth is typically the vertical extent of the bank.
- Bank angle is typically 90 degrees.

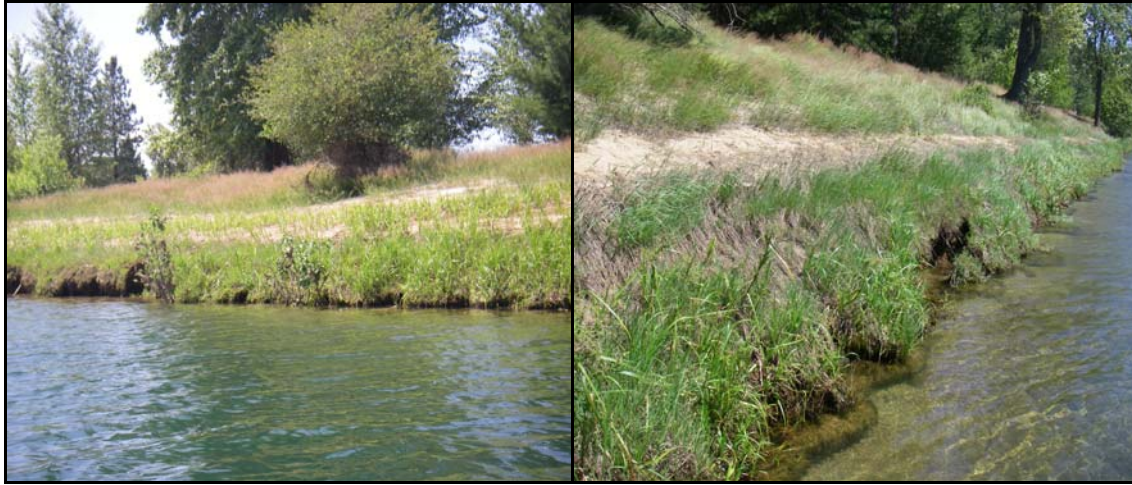
Bank Type 6

- Riverbank vegetation composed of grasses.
- Riverbank height is less than five feet.
- Root density is greater than 30 percent.
- Root depth is typically the vertical extent of the bank.

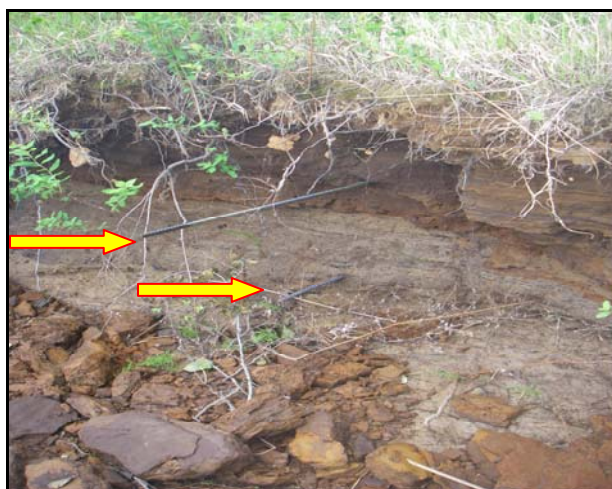
Figure 13. Photograph of exposed bank pins.

At each monitoring site, between one and three pins were driven horizontally into the bank, until the end of the pin was flush with the bank profile. The pins were half-inch diameter rebar, three feet long. As the bank receded from erosion, the pin was exposed. The length of the exposed pin was measured during each monitoring event then again driven flush with the bank profile. With repeated monitoring, a cumulative recession rate was calculated. This actual recession rate would help to answer whether there is a relationship between the recession rates for each bank type. Figure 13 displays an example of a bank pin site where bank recession has occurred, exposing an upper and lower pin.

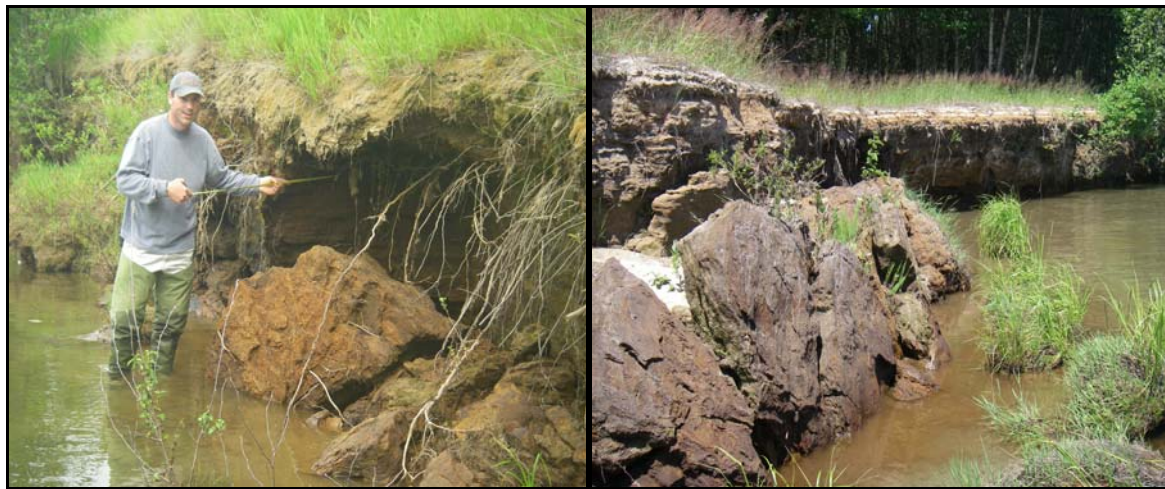
Figure 31. Undercutting and severe slumping of banks on the Lower Coeur d'Alene River.

In addition, Bank Type I had an Extreme Bank Erosion Hazard Index due to lack of vegetation and vertical banks. However, the tailings have created a cemented quality to the bank, which adds an element of protection of erosion thereby lowering the Bank Erosion Hazard Index. In the field, a unique erosion pattern was observed for the Type I, II and III banks, which were characterized by low root density and a bank angle of ninety degrees or greater. This erosion pattern was evidenced by undercutting, then slumping of bank in large blocks. Monitoring data suggests the frequency of this erosion pattern is likely greater than year time span. A few of the bank pin site locations did capture the loss of bank through slumping of a large block of bank, while others showed the undercutting phase of this pattern. The pictures in Figure 31 display two phases of this bank erosion pattern. In conclusion, more years of measured recession data will better capture and quantify this pattern and may validate the use of Rosgen BANCS methodology for estimating bank recession rates.

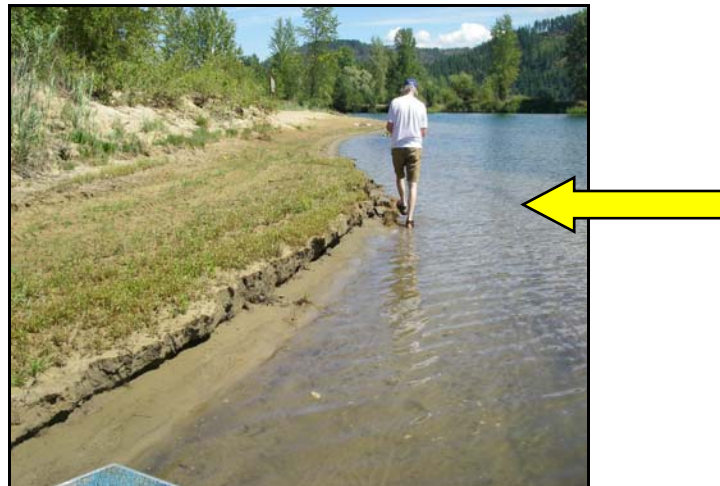
Figure 44. Site 11 on August 13, 2008

Visual observation of the bench along the inside meander (bank pin site locations 11 and 13) of the river channel revealed that large portions had been swept away during the Spring 2009 runoff. A rough estimate at site 11 would be about forty cubic yards and site 13 would be over one hundred cubic yards of sediment (Figure 44 through 47, arrows point to bench). This bench should be monitored to understand the dynamics of the flow and sediment transport caused by the dual erosion action from boat wakes and river flow, both of which play an integral part in the erosion dynamics of the lower Coeur d'Alene River.

Past studies have attributed the majority of the recession to boat wake activity. The significant recession observed on the inside meander banks support that statement. This study focused more on the effects and not the causes of bank recession. A monitoring of boat frequency and boat wake height in combination with the recession rate would be beneficial. Future bank pin monitoring of the relationship between the recession on the inside and outside bank of a meander will provide supporting information.
