**319 Grant**

**Mica Creek Sediment and Nutrition Reduction**

**FINAL REPORT**

**CR0180037**

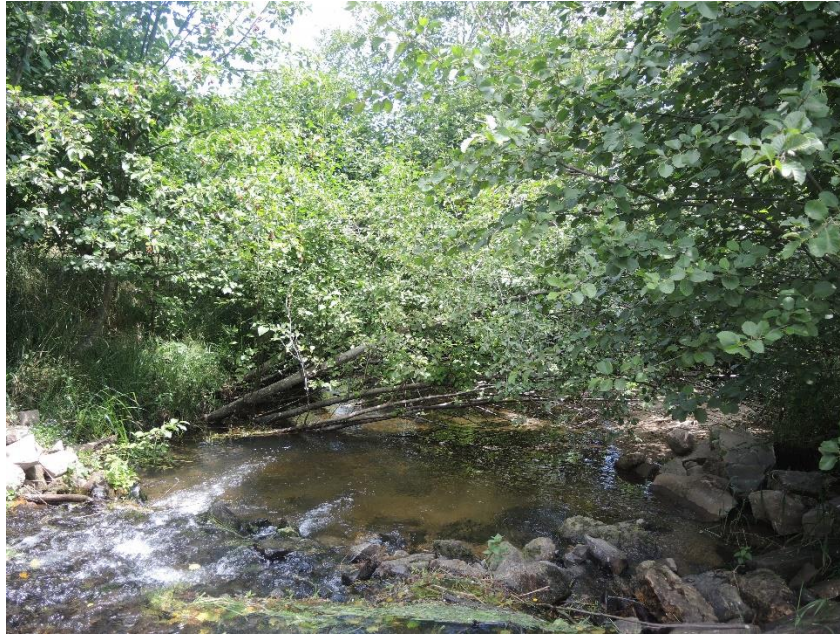
**Figure 2.** Site 1 Before Work Started

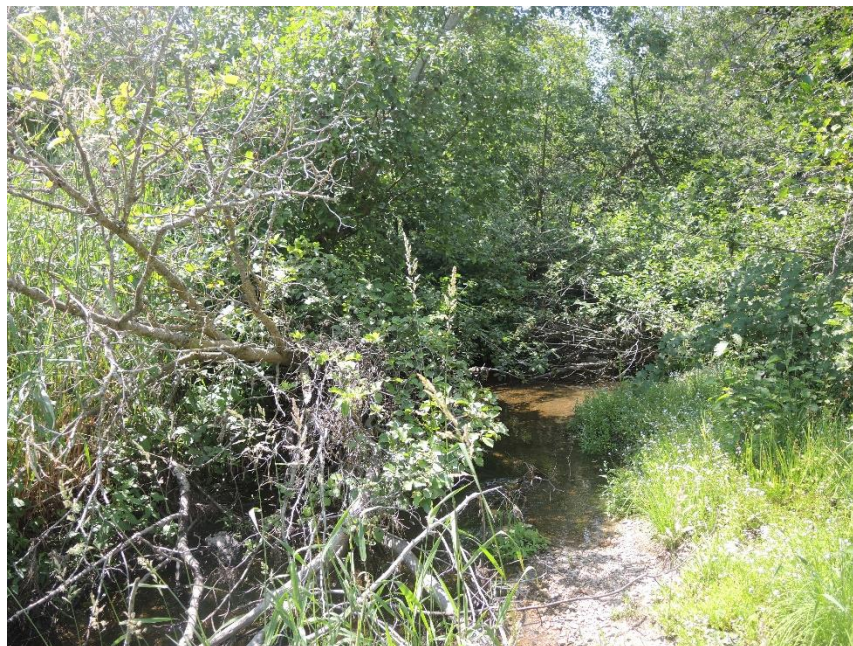
**Figure 3.** Site 1 Before Work Started

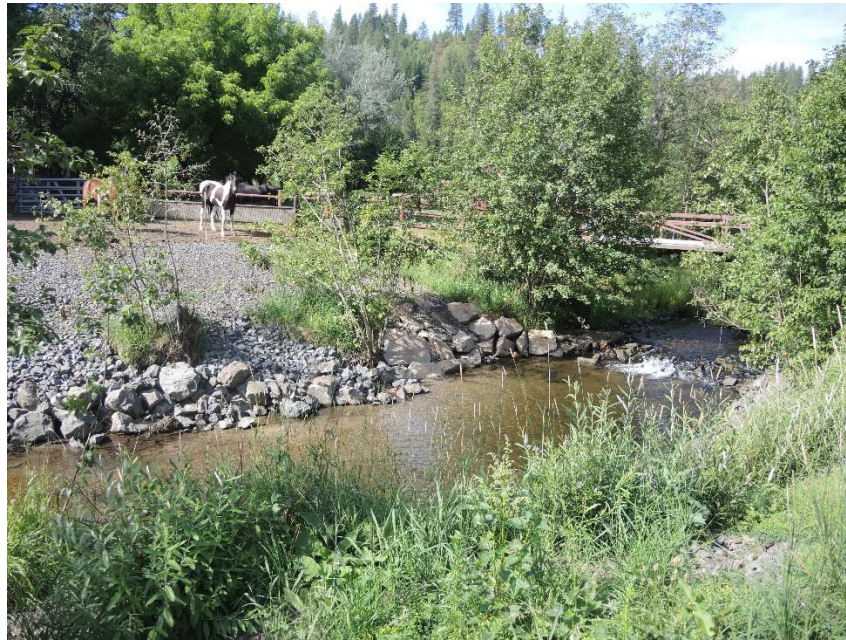
**Figure 4.** Site 1 After Completed Work

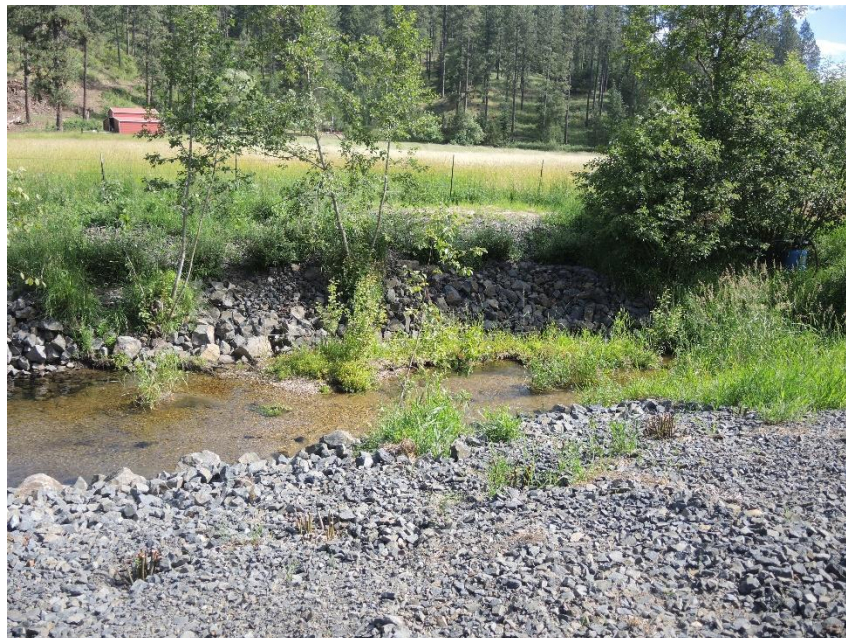
**Figure 2.** Site 1 After Completed Work

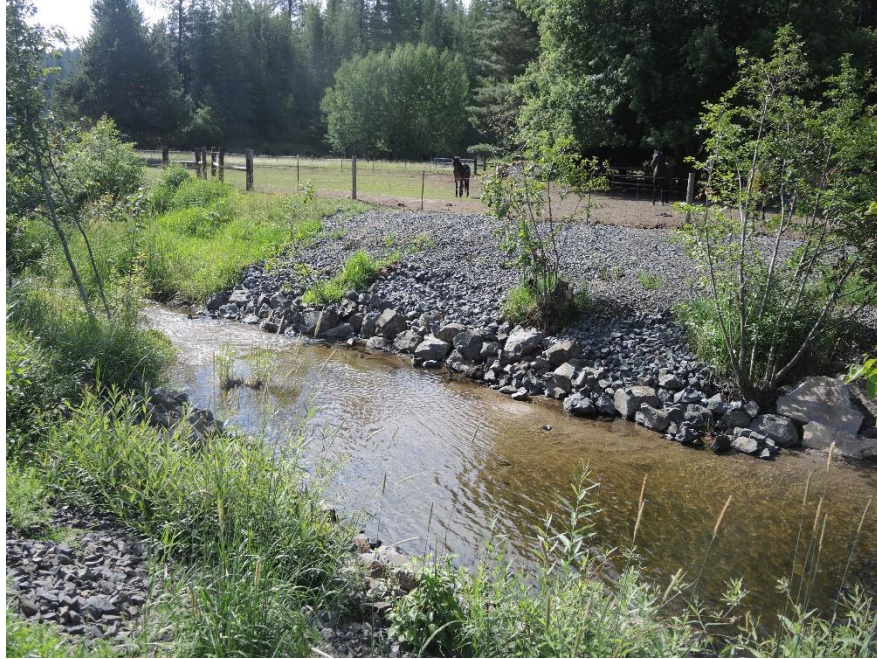
**Figure 3.** Site 1 After Completed Work

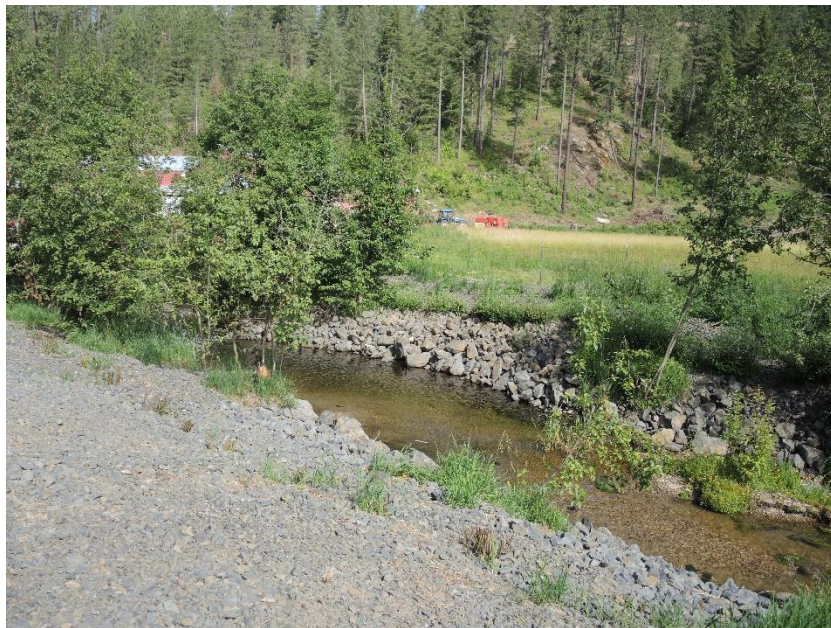
**Figure 4.** Site 1 After Completed Work

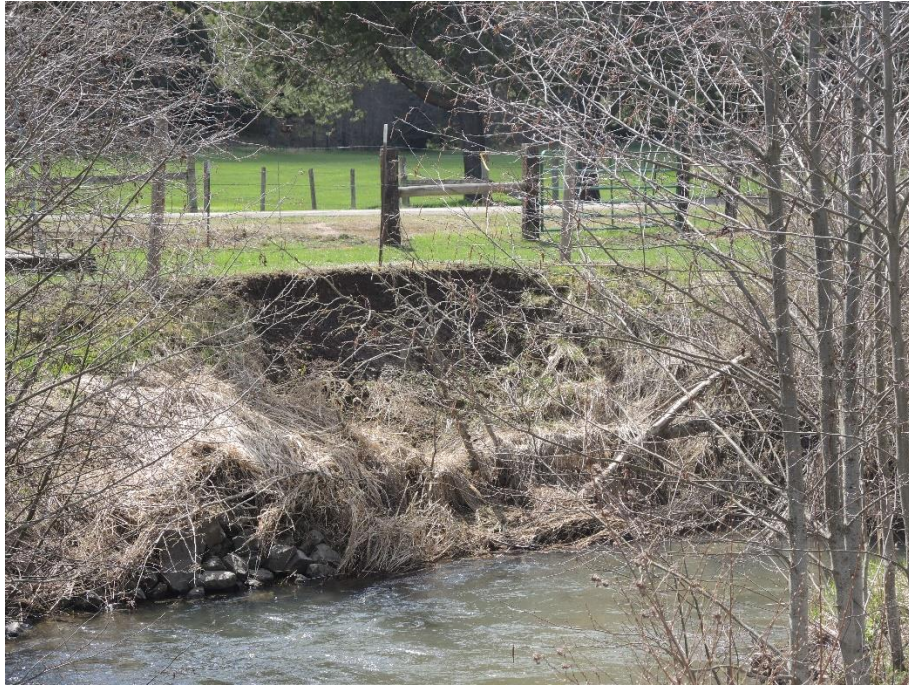
**Figure 5.** Site 2 Before Work Started

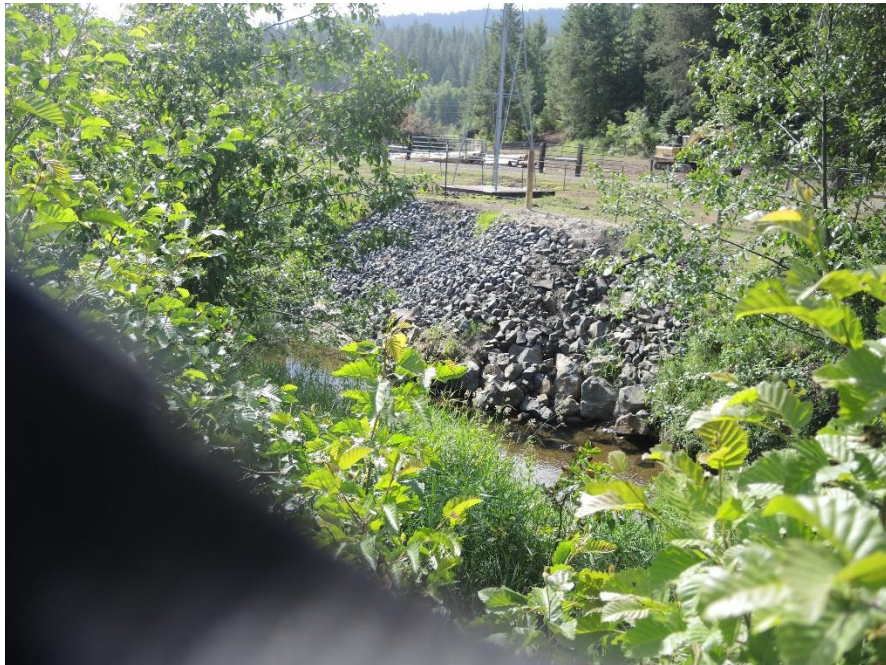
**Figure 6.** Site 2 After Work Completed

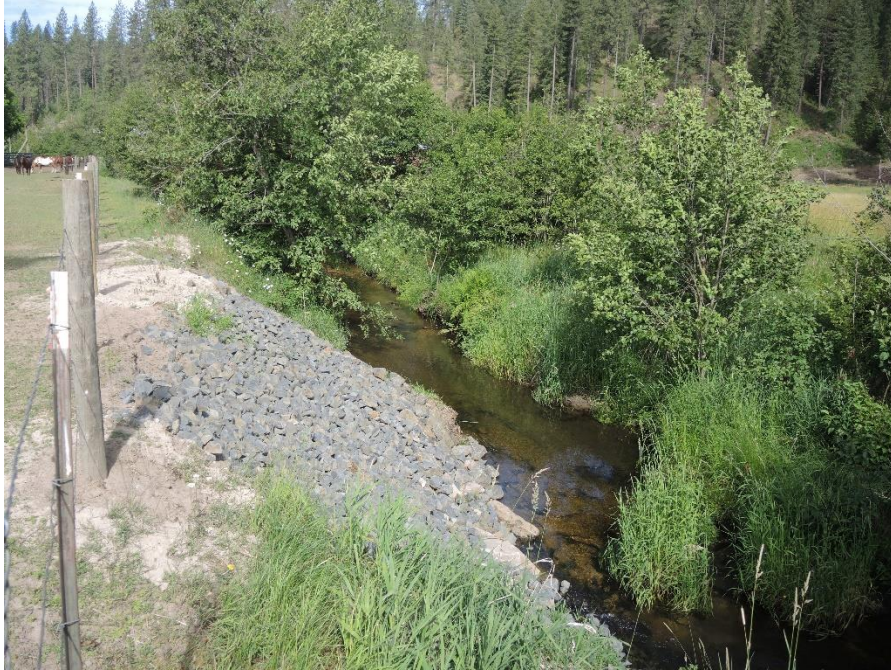
**Figure 7. Site 2 After Work Completed**

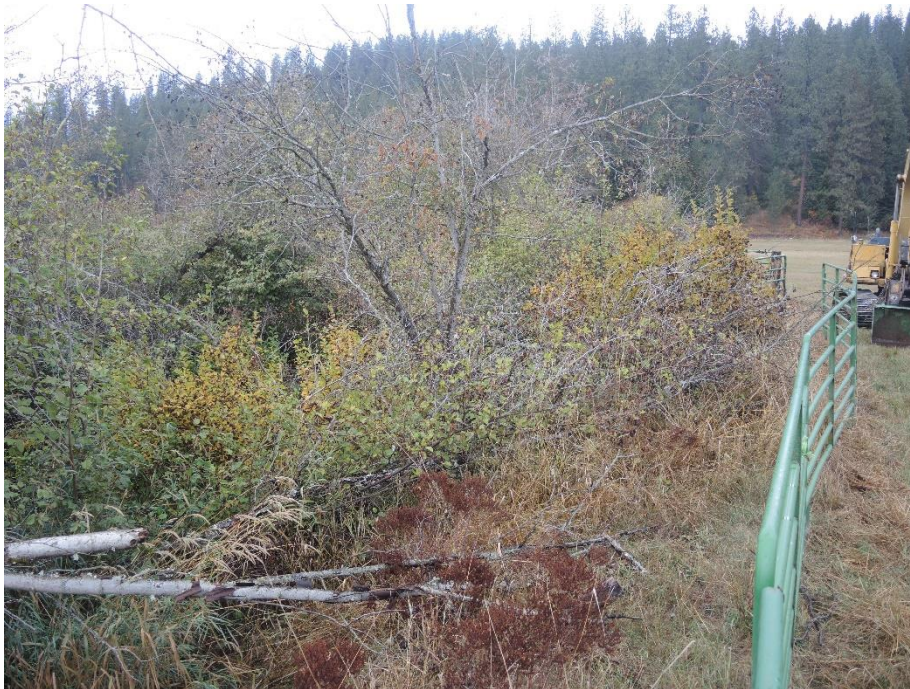
**Figure 8. Site 3 Before Work Completed**

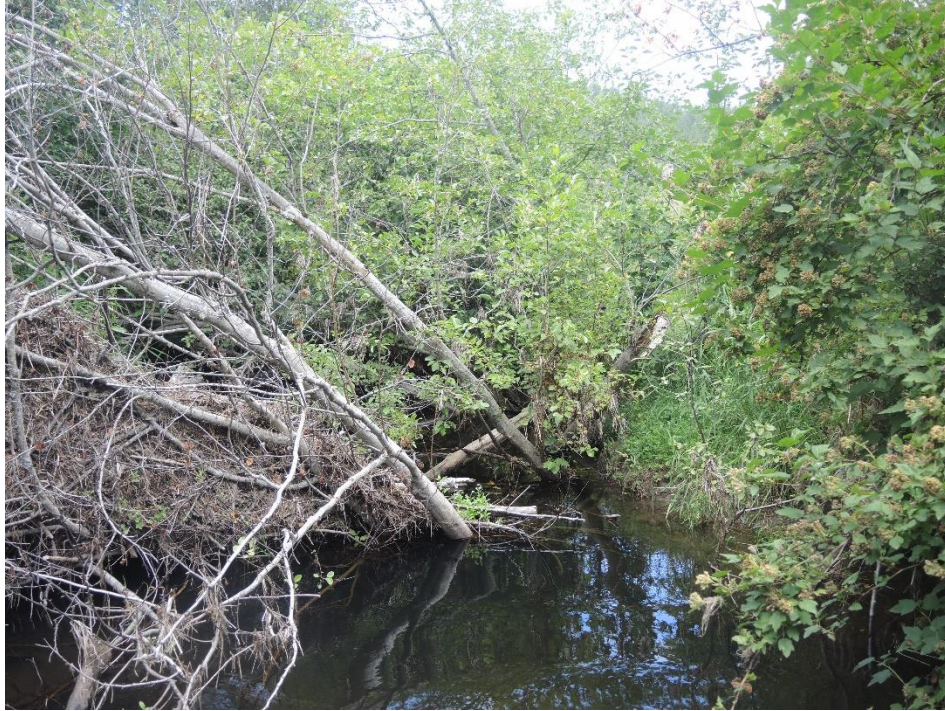
**Figure 9.** Site 3 Before Work Completed

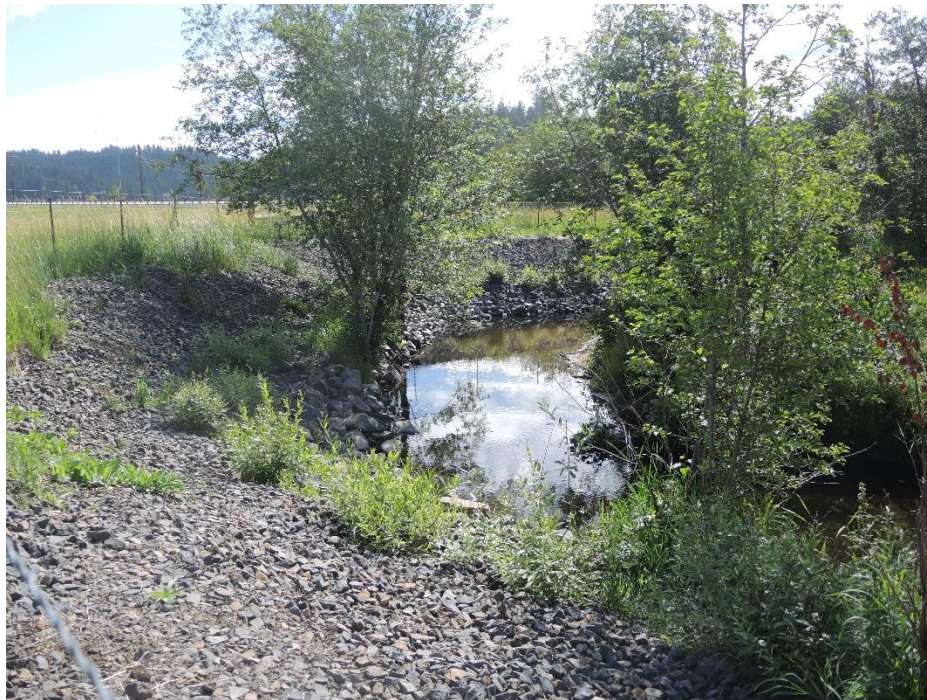
**Figure 10.** Site 3 After Work Completed

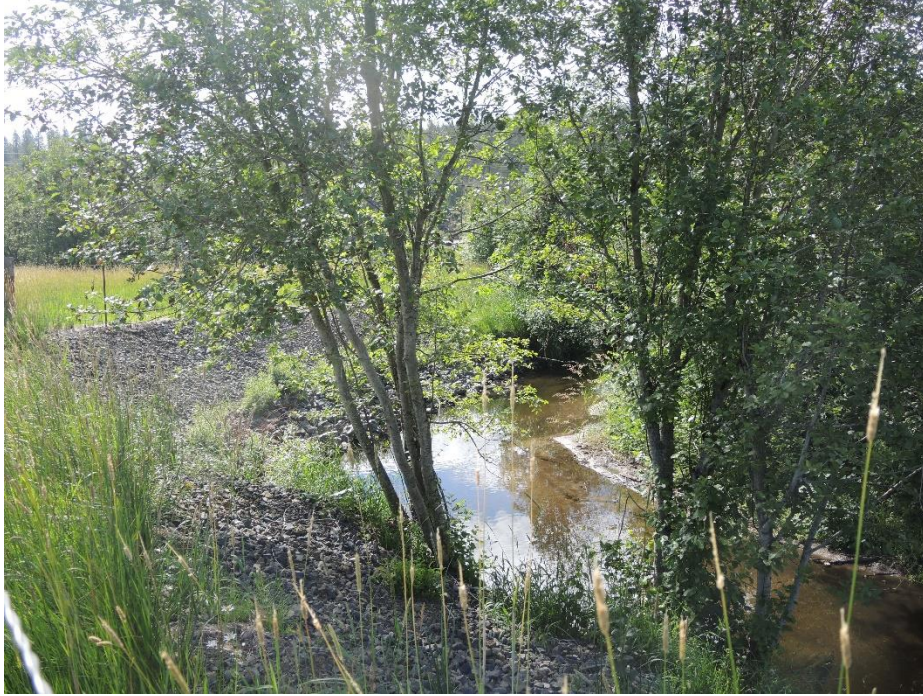
**Figure 11.** Site 3 After Work Completed

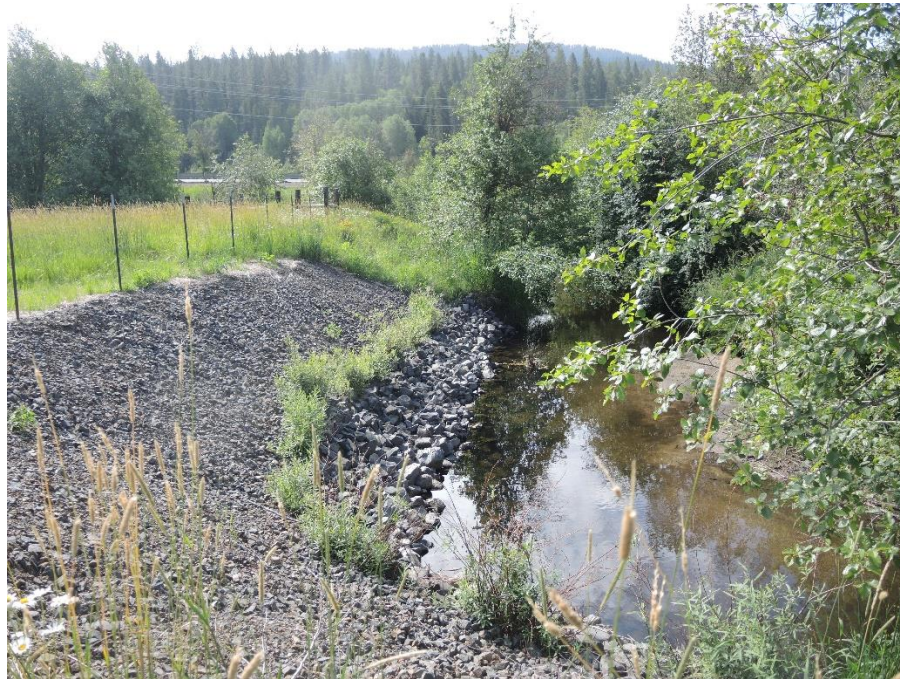
**Figure 12.** Site 3 After Work Completed

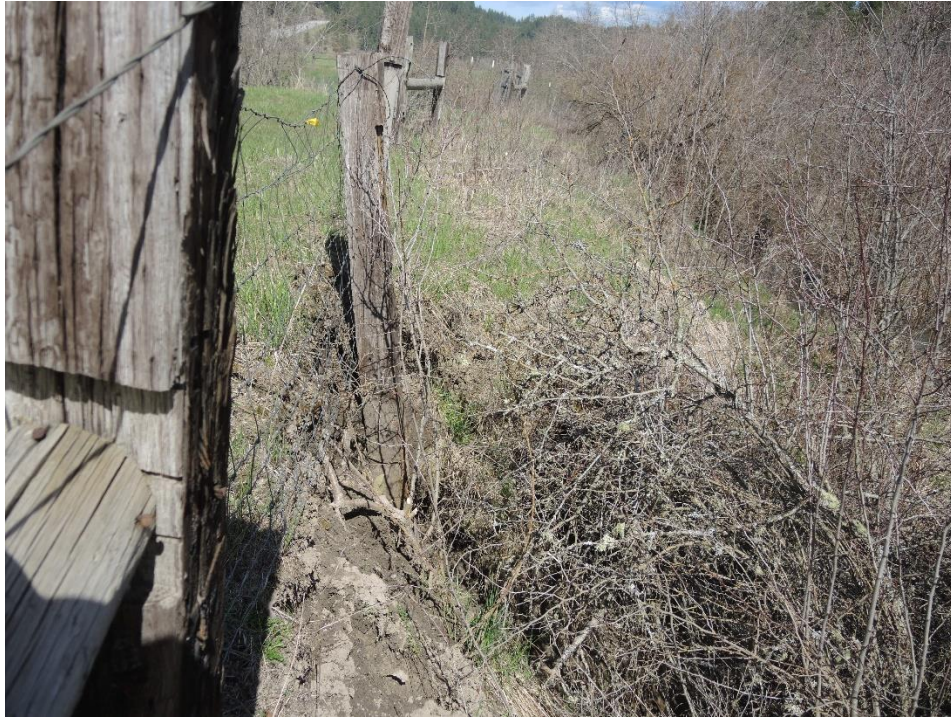
**Figure 13.** Site 4 Before Work Completed

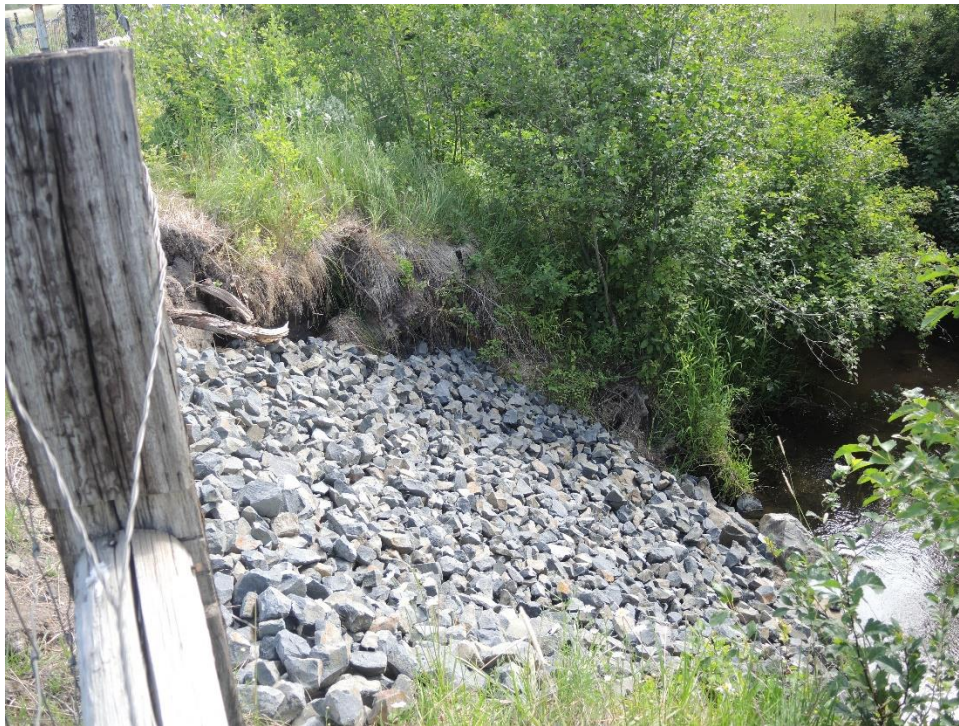
**Figure 14.** Site 4 After Work Completed

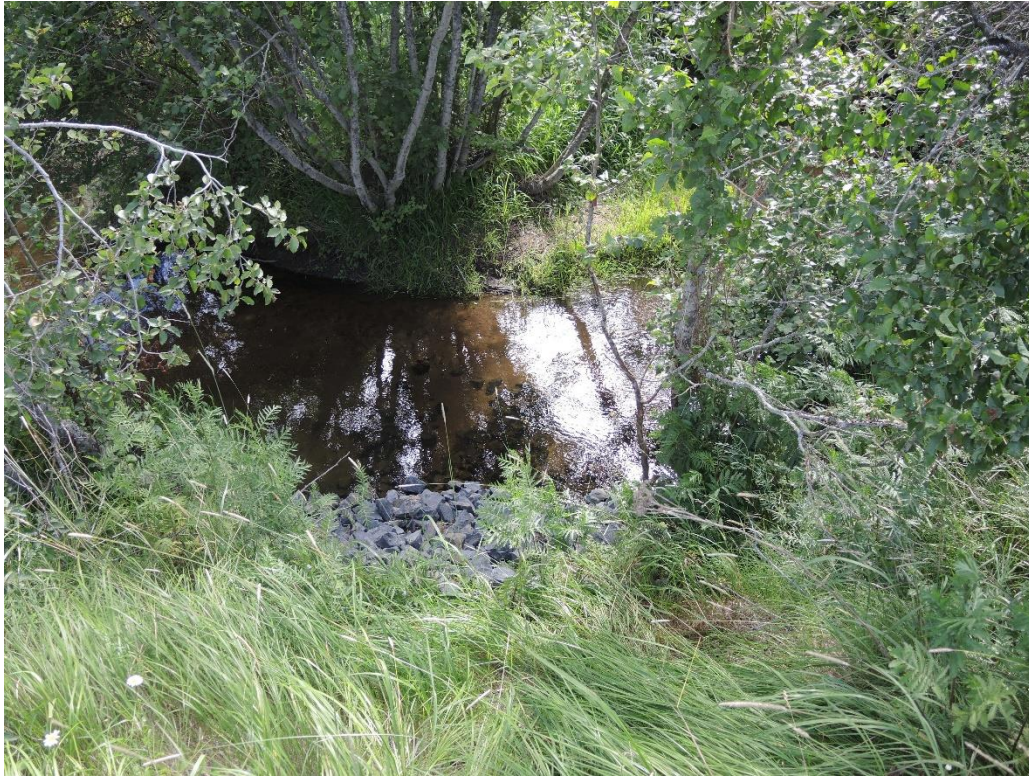
**Figure 15.** Site 4 After Work Completed

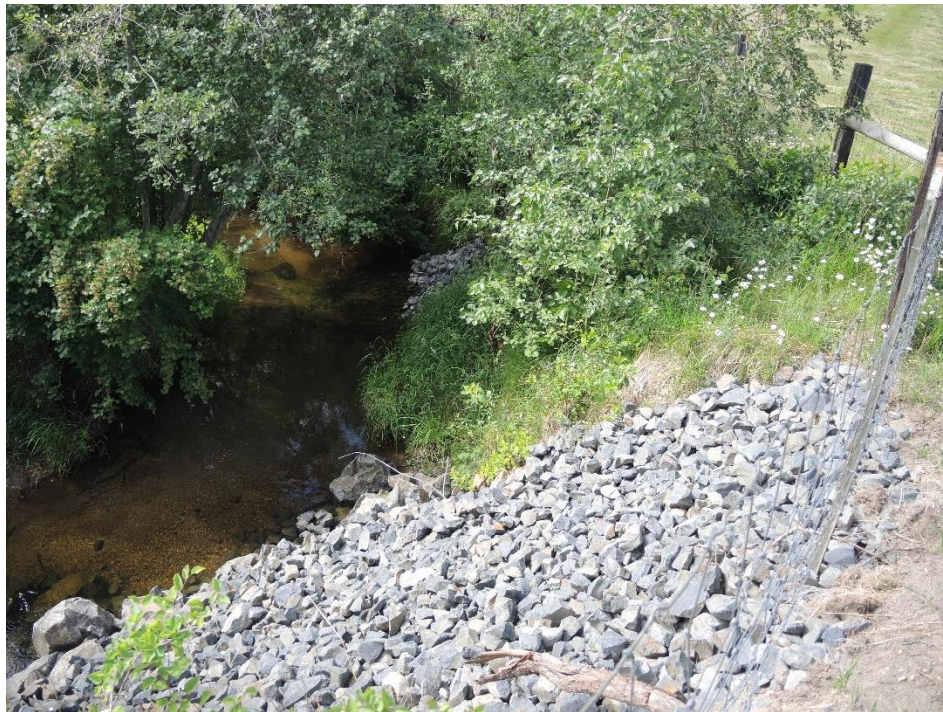
**Figure 16.** Site 4 After Work Completed

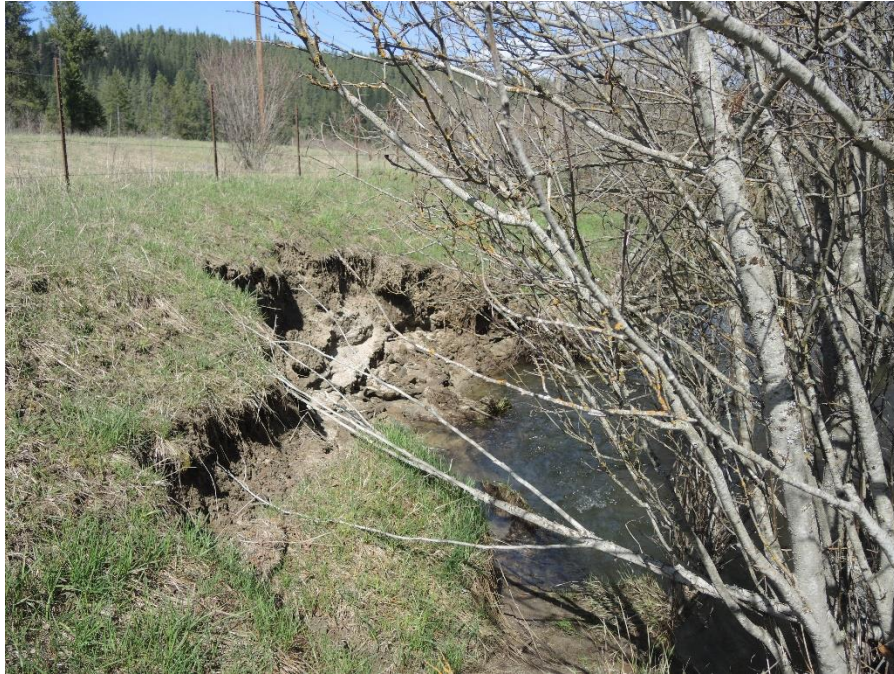
**Figure 17.** Site 5 Before Work Started

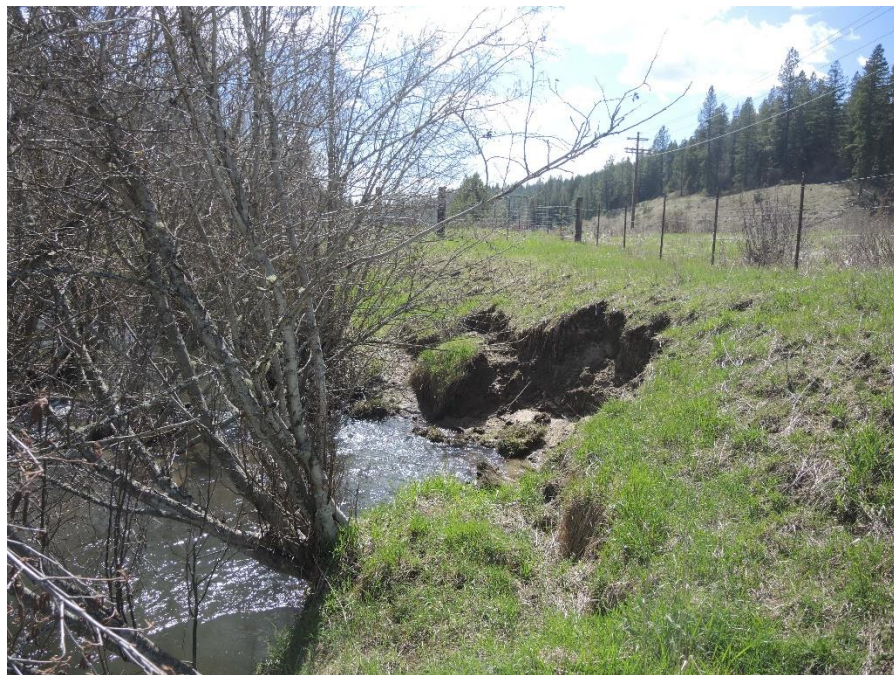
**Figure 18.** Site 5 Before Work Started

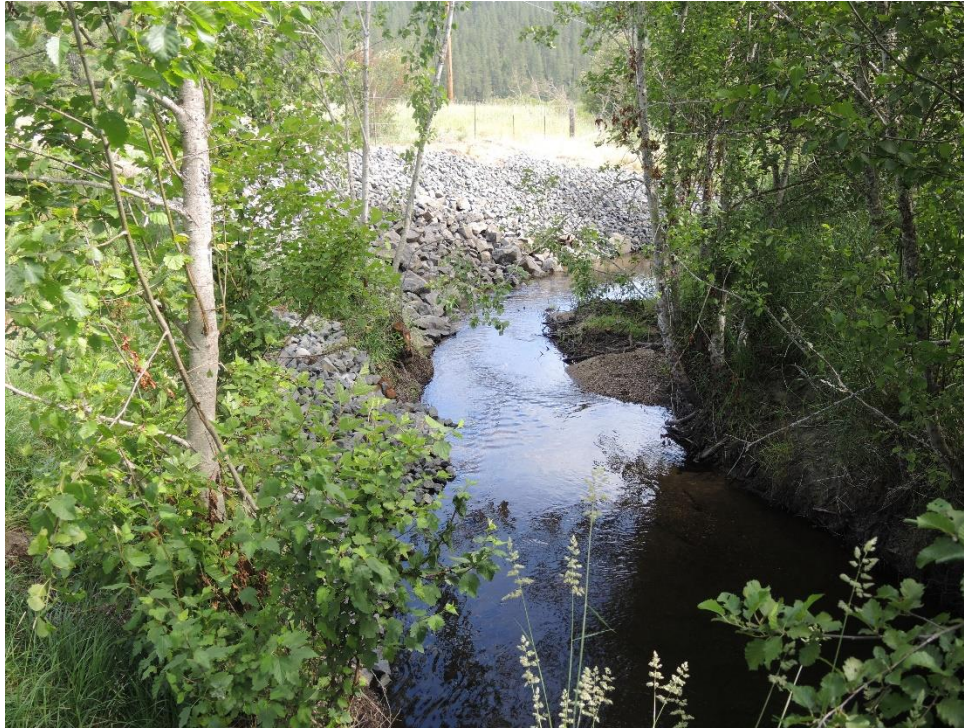
**Figure 19.** Site 5 After Work Completed

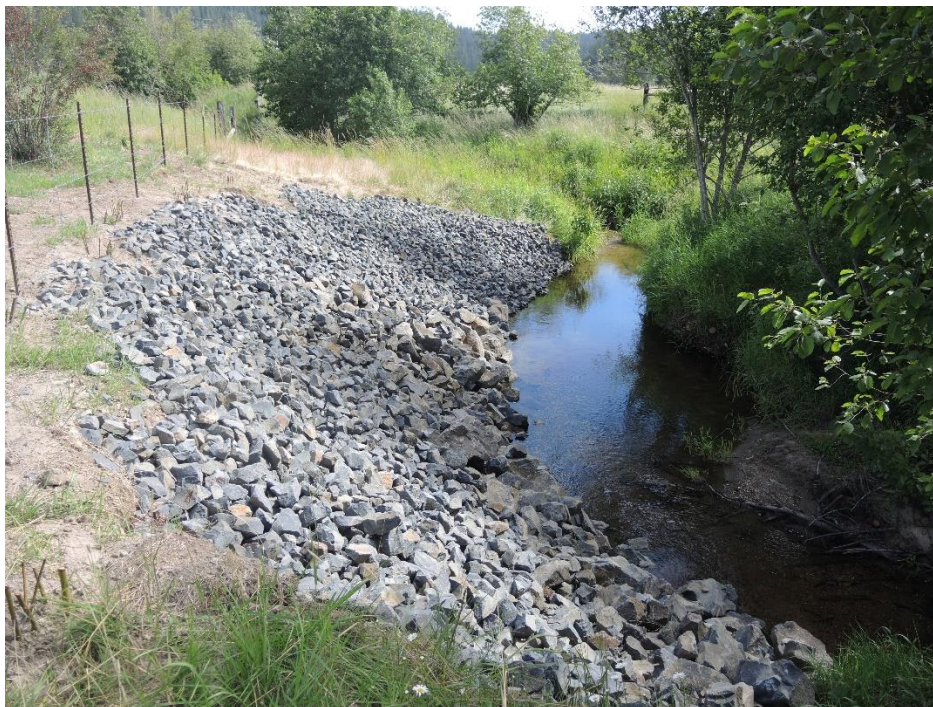
**Figure 20.** Site 5 After Work Completed

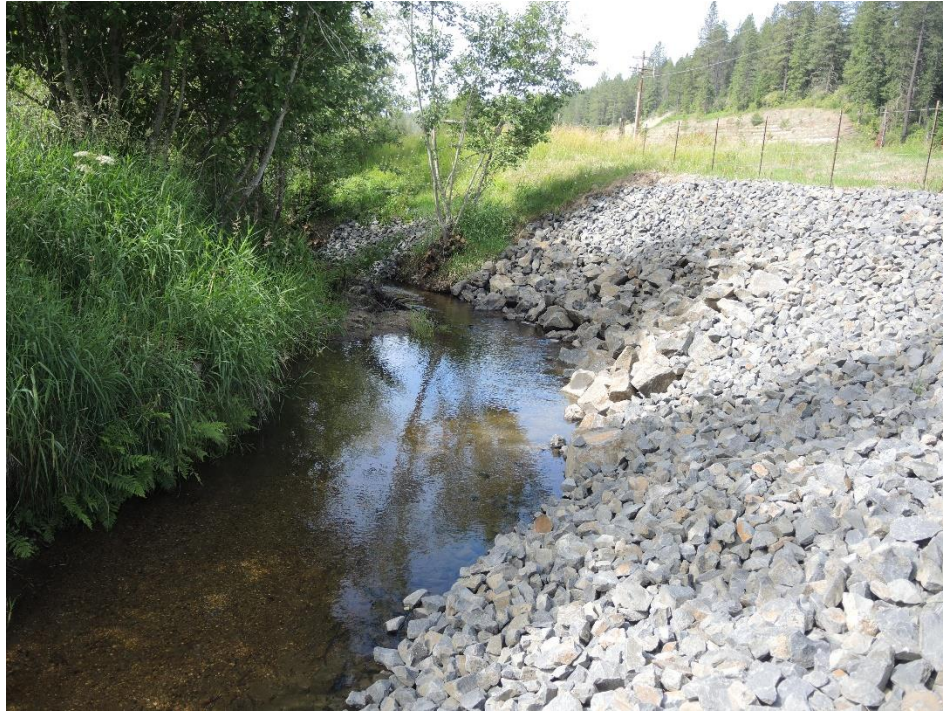
**Figure 21.** Site 5 After Work Completed

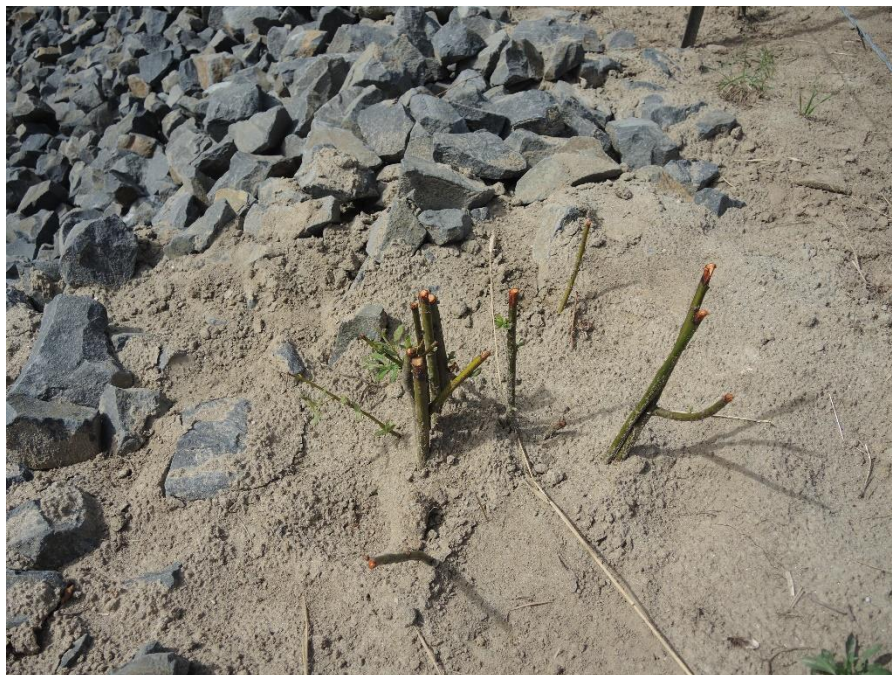
**Figure 22.** Site 5 After Work Completed. Willows planted
