Lower Coeur d'Alene Riverbank Stabilization Prioritization

Prepared by:
Kootenai-Shoshone Soil and Water Conservation District
7830 Meadowlark Way, Suite C-1
Coeur d'Alene, Idaho 83815
(208) 762-4939
Craig Nelson and Bob Flagor

In Cooperation with Idaho Department of Environmental Quality
Coeur d'Alene Regional Office
2110 Ironwood Parkway
Coeur d'Alene, Idaho 83815
Kristin Keith and Thomas Herron

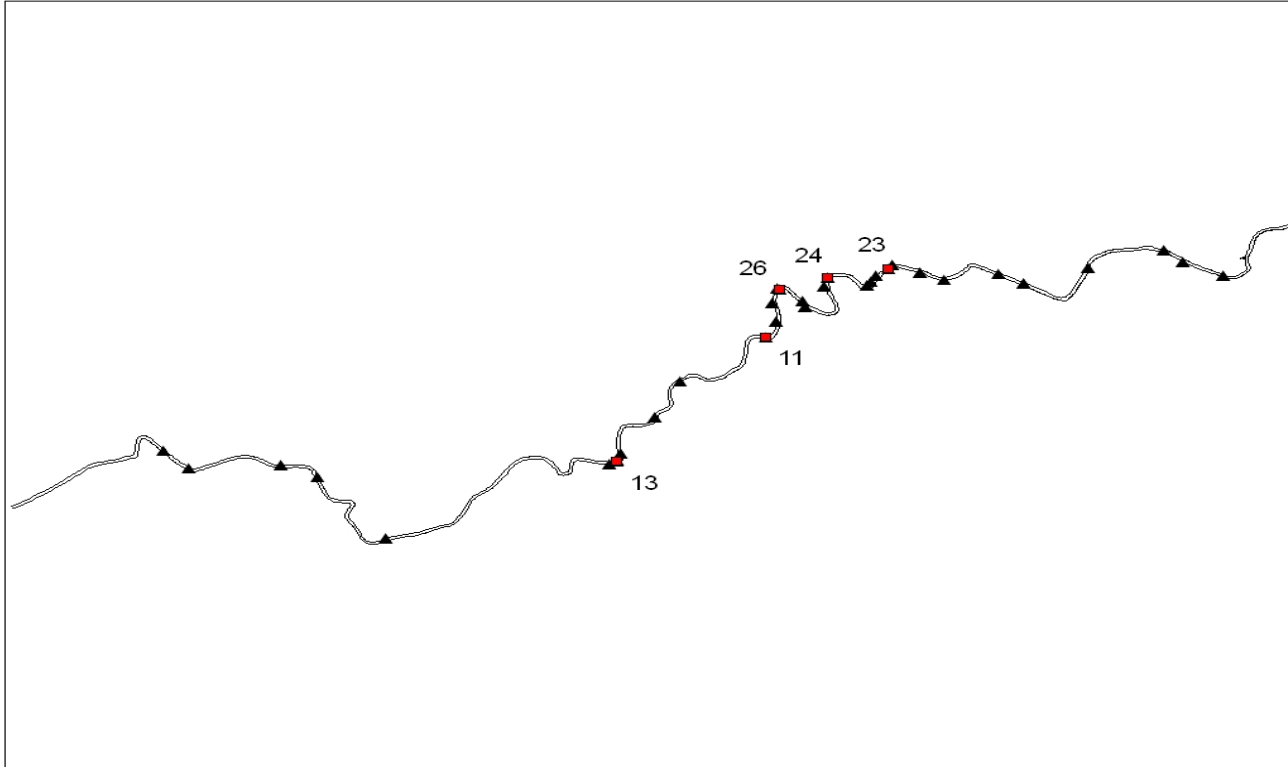
Figure 14. Site locations with measured recession prior to spring runoff:

After the pins were installed on July 16, 2008, a partial monitoring event was performed on August 13, 2008. A complete monitoring of all 36 sites was accomplished on October 30, 2008, and November 19, 2008. Erosion observed during the July-August time frame would be primarily associated with bank erosion from boat wake activity. Table 2 displays the measured recession prior to spring runoff, with the unlisted sites having no measured recession. This recession occurred at the inside bank of a meander, where a sandy point bar exists (Bank Type 4) (Figure 14).

Monitoring Event 8/13/08				
Site	Bank Type	Location		Recession in Inches
11	4	inside meander	only one pin	126
13	4	inside meander	only one pin	96
26	4	inside meander	only one pin	13.2
Monitoring Event 10/30/08				
Site	Bank Type	Location		Recession in Inches
11	4	inside meander	only one pin	21
13	4	inside meander	only one pin	24
24	1	inside meander	lower pin	0.25
Monitoring Event 11/19/08				
Site	Bank Type	Location		Recession in Inches
23	4	inside meander	only one pin	41
26	4	inside meander	only one pin	7.6

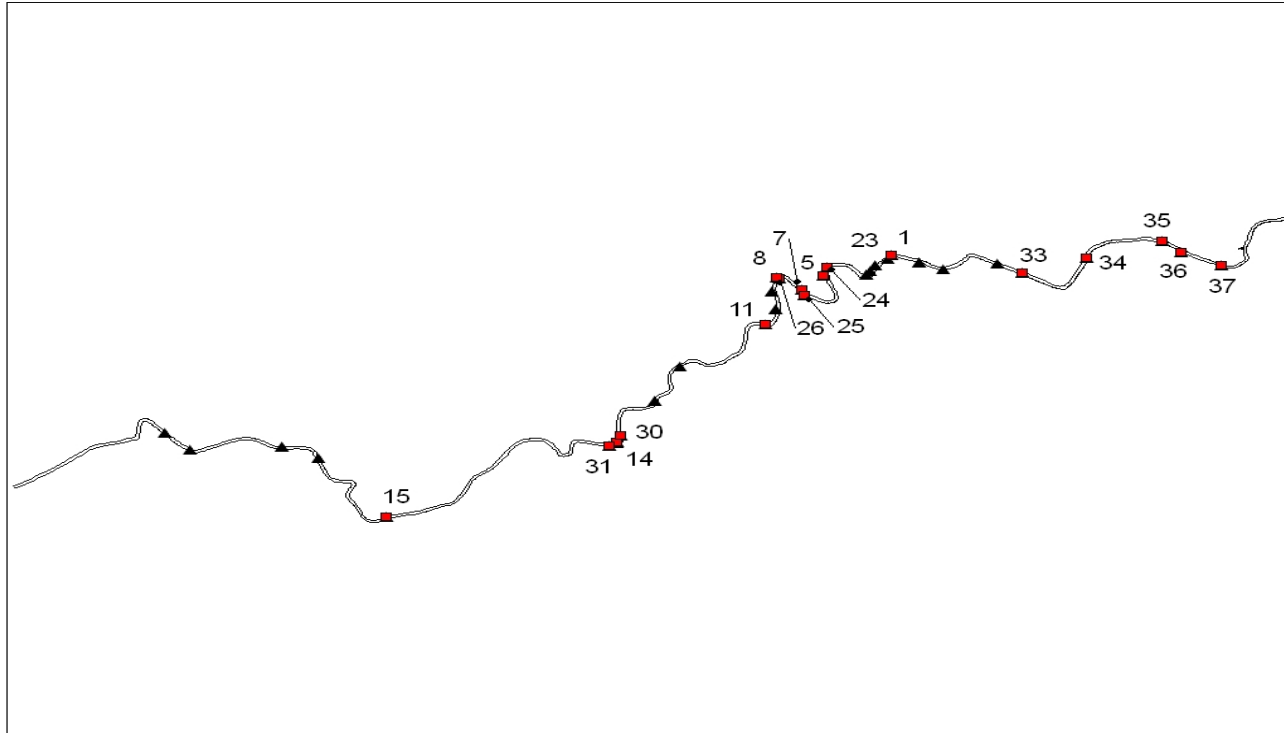
Figure 15. Site locations with measured recession after spring runoff.

After spring runoff, a complete monitoring event occurred between June 15 and June 17, 2009. A total of 36 sites were monitored. This monitoring event was designed to capture bank recession rate which occurred between November 19, 2008, and June 17, 2009 — a time period primarily associated with runoff. During this monitoring event, some of the pin sites were lost, and recession rate could not be measured for following reasons: 1) the site was covered with riprap stabilization during the winter months, (sites 4, 9, 12, 16, 17, and 27); 2) the site could not be located (sites 18 and 23). Despite this loss, bank recession rate was captured at 25 pin sites after the spring runoff. Table 3 displays the measured recession after spring runoff, Table 4 lists average recession rate by bank type, and Figure 15 shows site locations. Bank type 4 continued to show significant recession. Generally, bank types 1, 2, and 3 receded approximately one foot. Bank type 5 receded less than half a foot and bank type 6 had no measured recession.

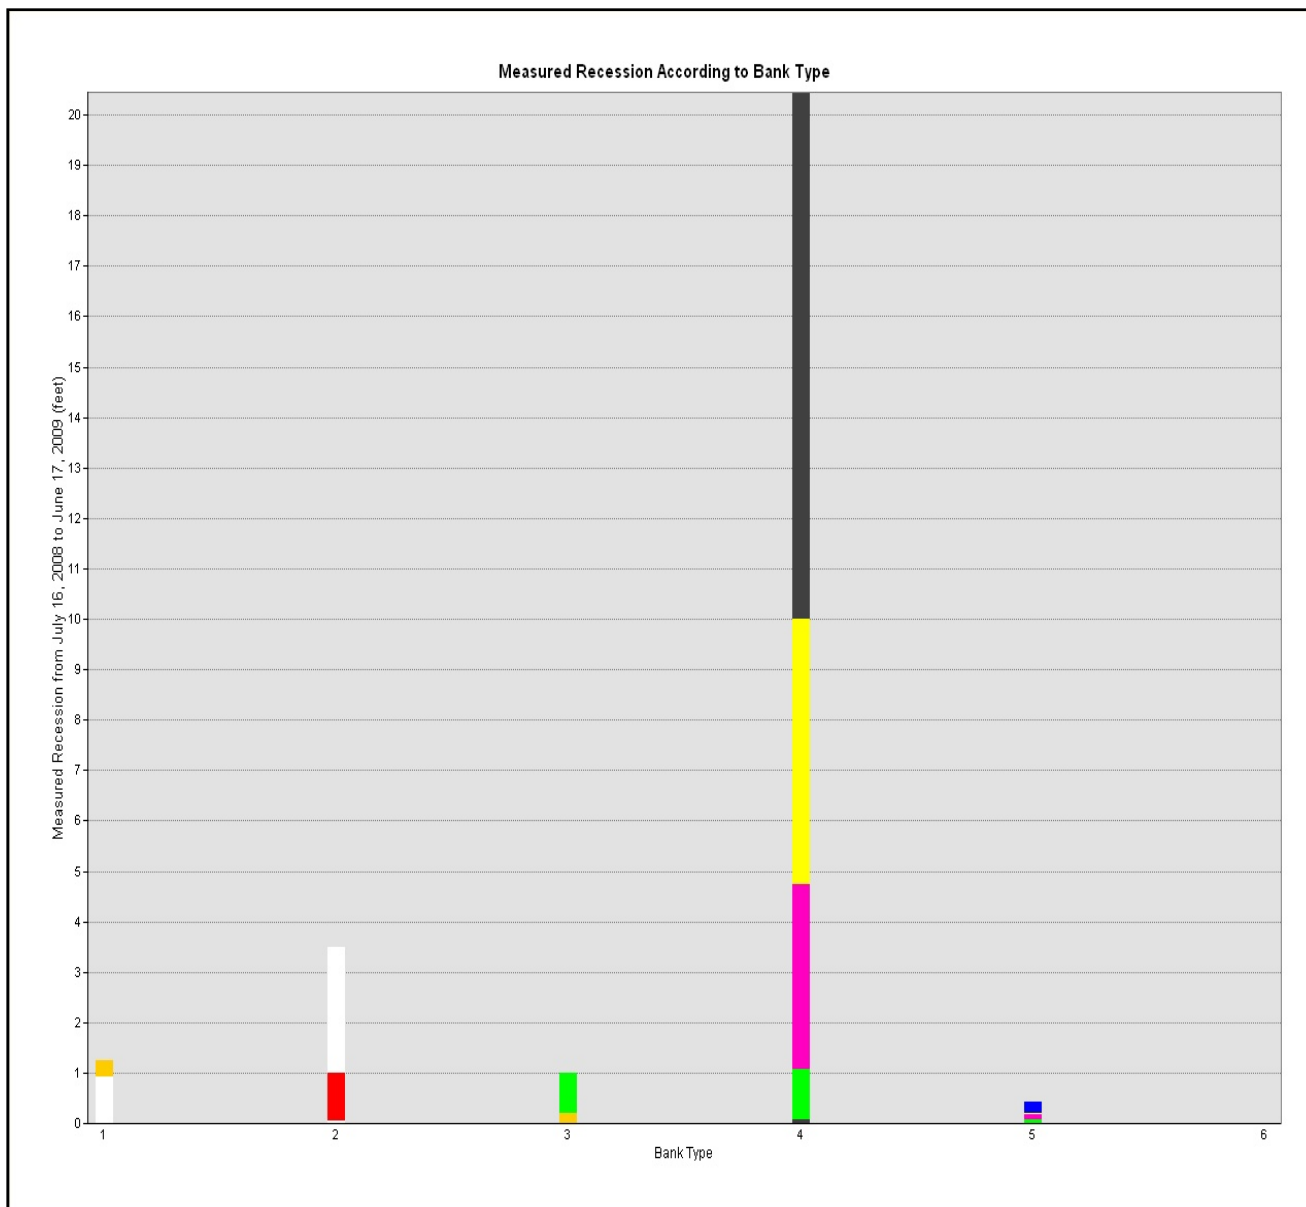
Figure 16. Measured recession according to Bank Type

Figure 16 displays the measured recession from July 16, 2008 to June 17, 2009, according to the bank type. The color blocks indicate the total recession at different horizontal monitoring pin bank site locations. Significant recession occurred at bank type 4 locations, which are the dynamic inside meander sandy point bars. Bank type 1, 2, and 3 showed a measurable difference in recession compared to bank type 5 and 6. This difference seems to be attributed to the higher root density and depth from vegetation for bank type 5 and 6. The lack of a measurable recession for bank type 6 would be attributed to, not only the root density and depth, but the less severe bank angle.

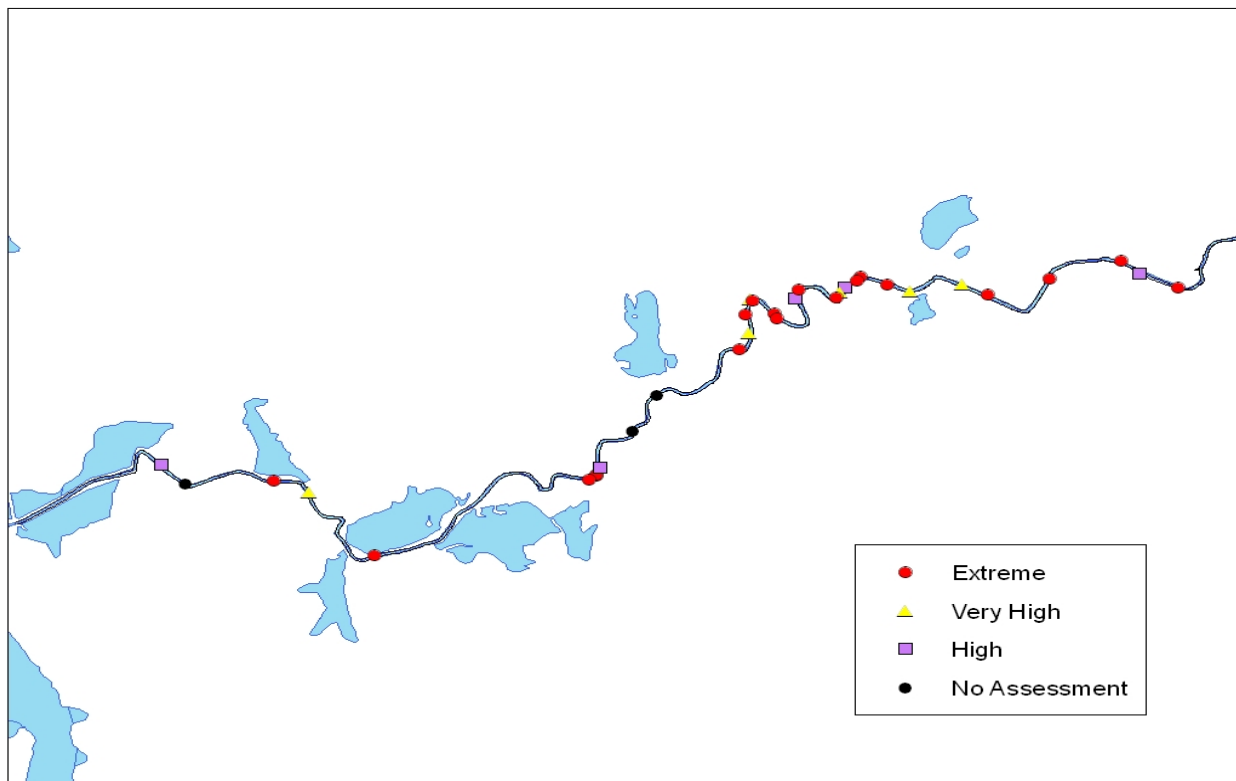
Figure 23. BEHI rating at each bank pin site

The sum of the individual variable rating scores produced a total score with an overall BEHI rating at each bank pin site (Figure 23).

This assessment was performed at each bank pin site location, excluding sites 12, 18, and 27. Site 12 and 27 were armored, and site 18 was missed in the assessment. The BEHI scores at each bank pin site location, with five site locations representing each bank type, were averaged to produce an average BEHI score and rating for each bank type (Table 5). According to this assessment, the Lower Coeur d’Alene riverbanks are all highly susceptible to erosion.

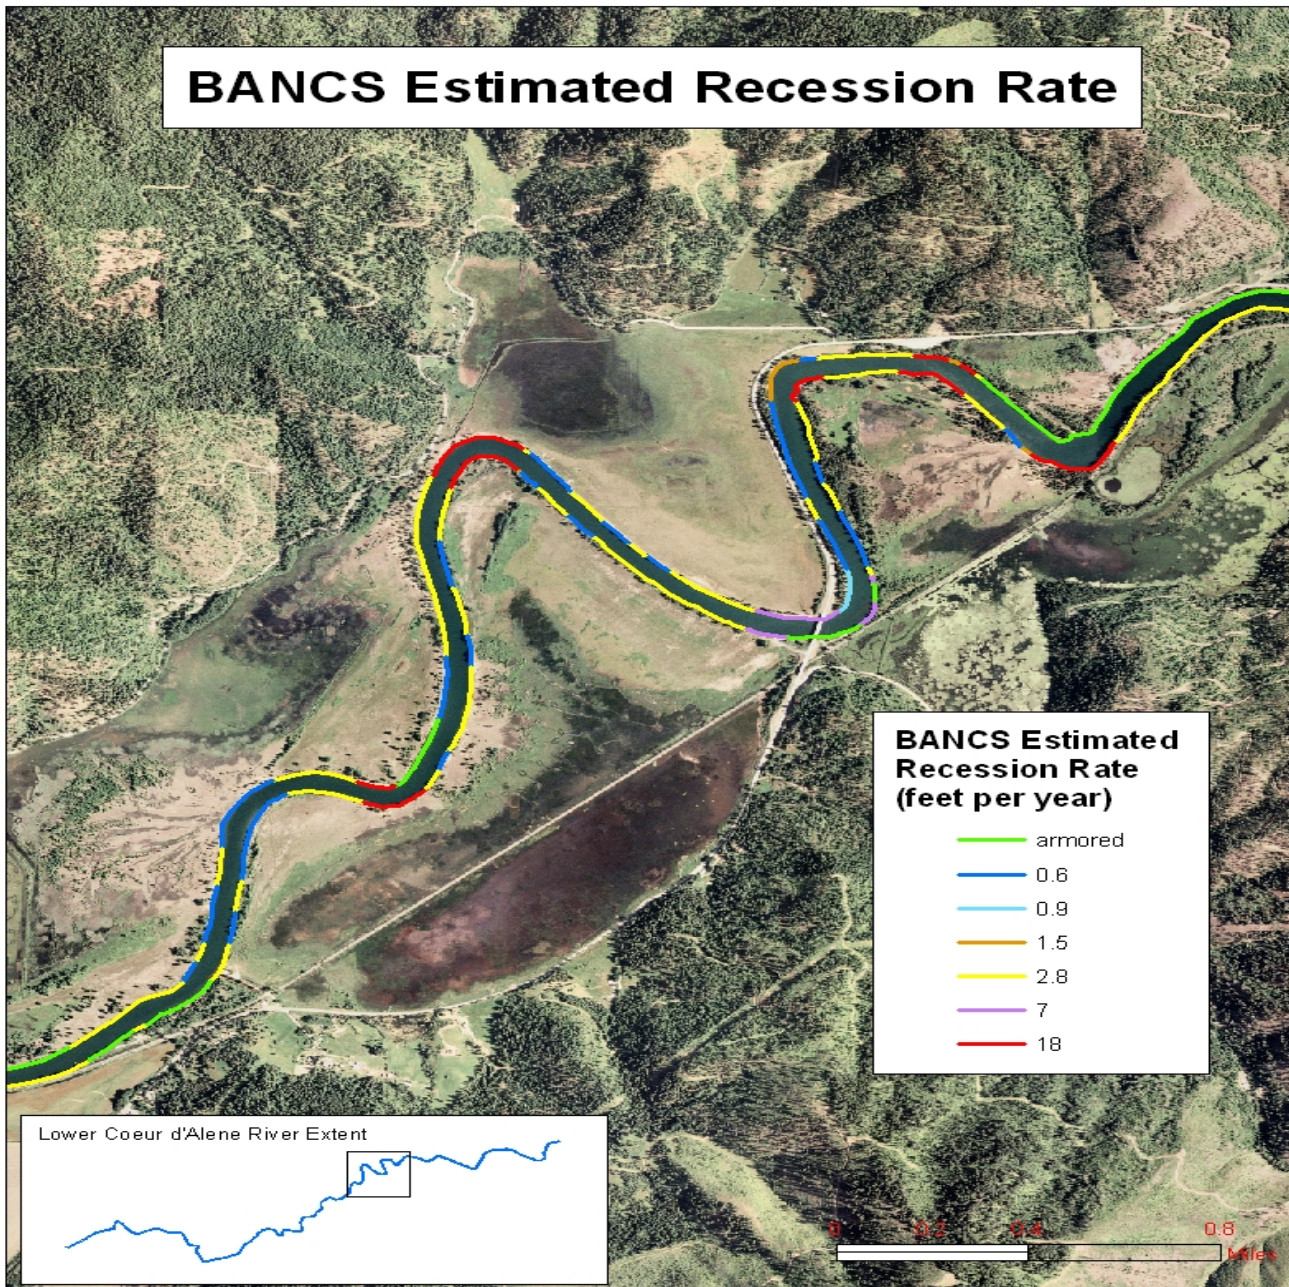
Figure 27. Estimated recession rate using the BANCS model

The relationship between BEHI and NBS (ratio of radius of curvature to bankfull width) can establish an estimated bank recession rate (feet/year) for the Lower Coeur d'Alene River extent using the Bank Assessment for Non-point source Consequences of Sediment (BANCS) model (Rosgen, 2006). The prediction of annual streambank recession rates was based on Colorado United States Department of Agriculture Forest Service (1989) data for streams found in sedimentary or metamorphic geology. This estimated recession rate for the Lower Coeur d'Alene River was then evaluated for accuracy by comparing it with the actual recession rate measured at the pin site locations. A visual display of the estimated erosion rate is provided in Figure 27.

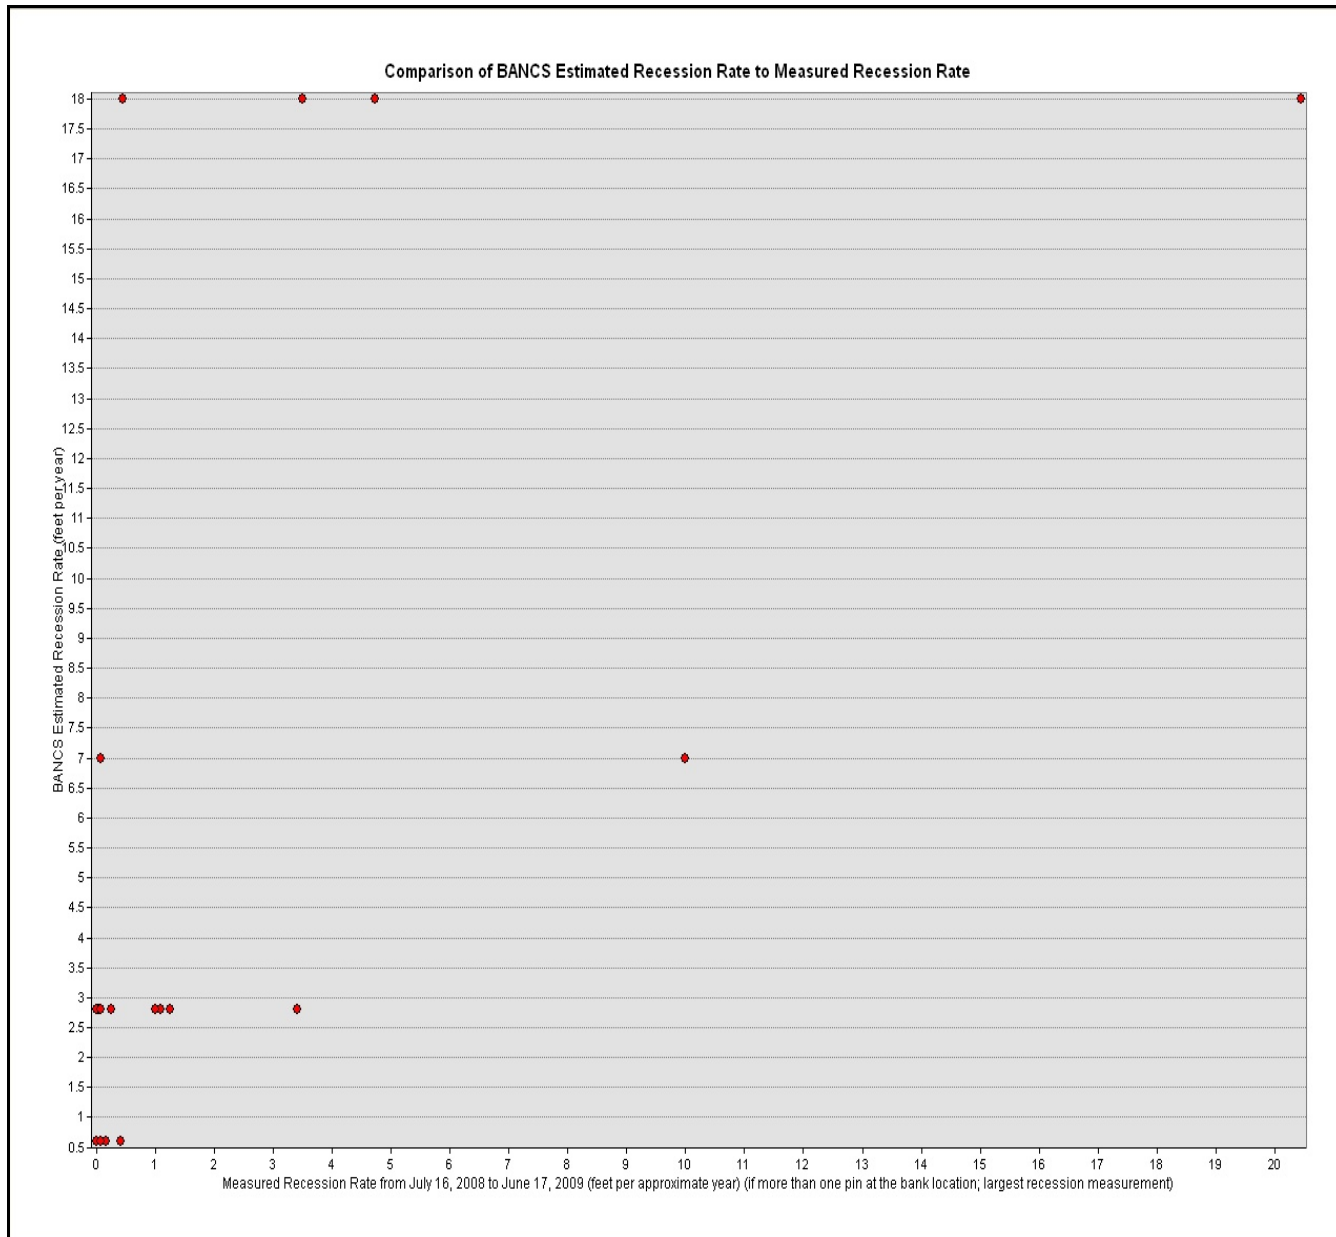
Figure 28. Comparison of recession rate using BANCS model and measured recession rate

An important component of validation of the BANCS model estimate of recession rate on the Lower Coeur d'Alene River banks is a comparison with actual bank pin erosion monitoring data at select sites along the project extent. The scatter plot in Figure 28 compares the estimated bank recession rate (feet/year) using the BANCS model and the actual measured recession from July 16, 2008, to June 17, 2009, monitored using the horizontal bank pins. As evidenced in the graph, no solid relationship was established between the two methods.

This poor correlation can be attributed to several factors. The lower Coeur d’Alene River is a tailings-impacted, multi-stage channel due to upstream mining activity and backwater conditions during the summer. As such, Rosgen’s Near Bank Stress prediction methodology and Bank Erosion Hazard Index may not apply to this system. The Near-Bank Stress methodology assumes disproportionate distribution of shear stress in the near-bank region of flow. However, during the season of inundation, erosion of the stream bank from boat wakes is a primary factor, with any shear stress from flow being relatively non-existent. This was evident on inside meanders of the river channel, which had a higher recession rate than the outside meanders during the first year of monitoring (Figure 29). In normal stream systems, the inside meanders are usually a depositional zone, creating sandy point bars. However, in systems that have high boat wake action, the highest stress is applied to the inside of the meander, where the wake energy is concentrated. This is illustrated in Figure 30. The inside meander in the Lower Coeur d’Alene system is therefore very dynamic.

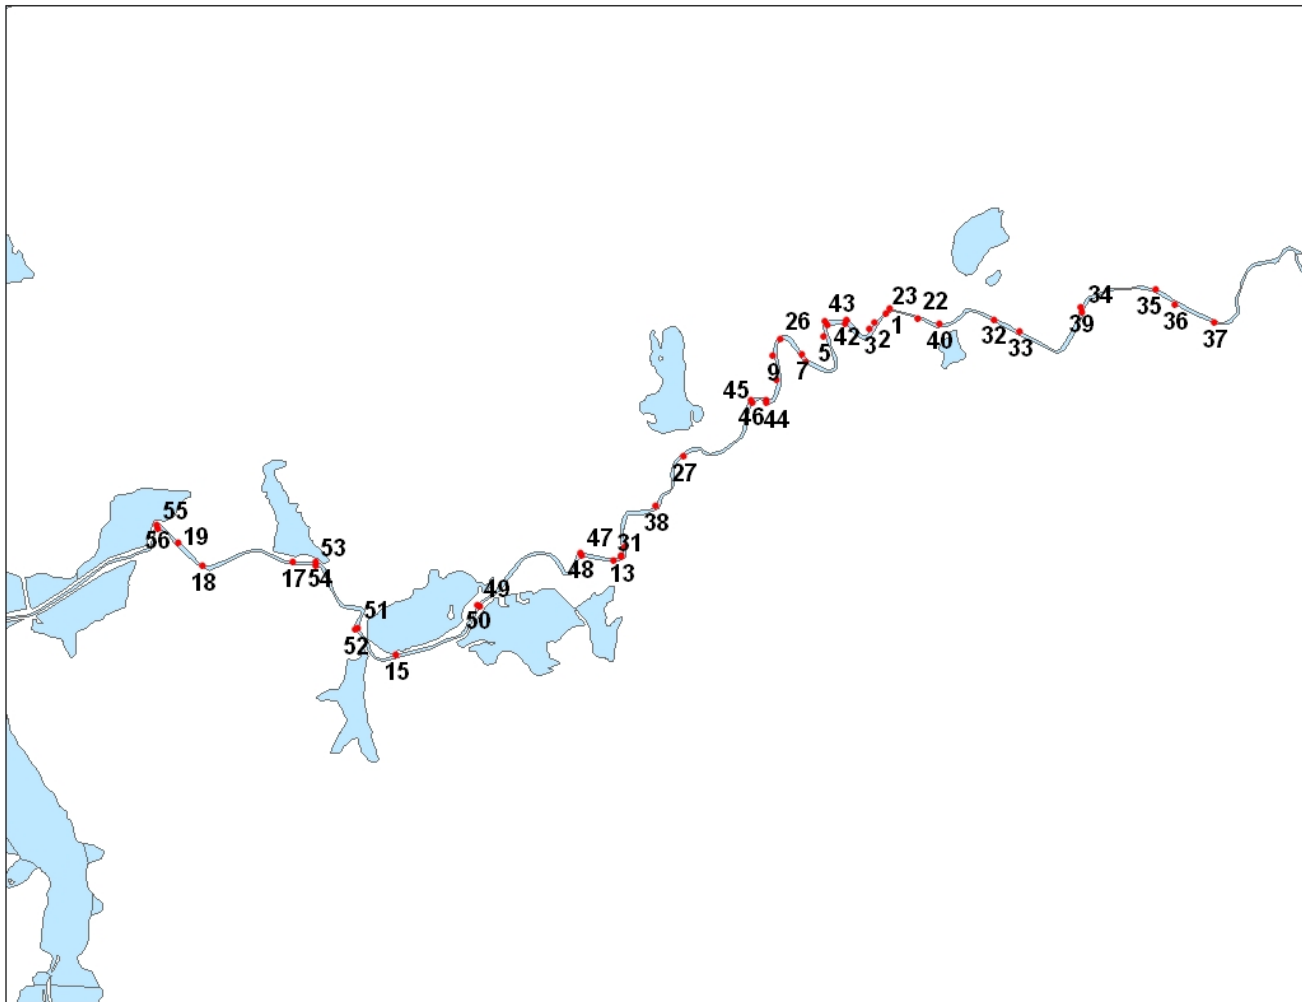
Figure 32. Current bank pin site locations (June 17, 2009).

Bank pin monitoring will continue along the lower Coeur d'Alene River to better understand the relationship between recession at the inside bank compared to the outside bank of a meander. Additional bank pins were installed during the last monitoring event on June 17, 2009. These new sites not only replaced some of the original sites that no longer exist, but were strategically located to optimize distributions among several variables. The variables include bank type, bank side, bank location with reference to meanders, and the radius of curvature classification. Future monitoring may explain the relationship of the variable to the recession rate. ArcGIS was used to represent a distribution within these variables while minimizing the amount of new sites, with the primary purpose for the new sites to be placed on the inside and outside bank of a meander. Nineteen new sites were added to the twenty-eight existing sites for a total of forty-seven current sites (eighty-three pins total). Within this total, twelve meanders have bank pin site locations capturing the recession on the inside and outside banks of the meander (Figure 32 and Table 6).

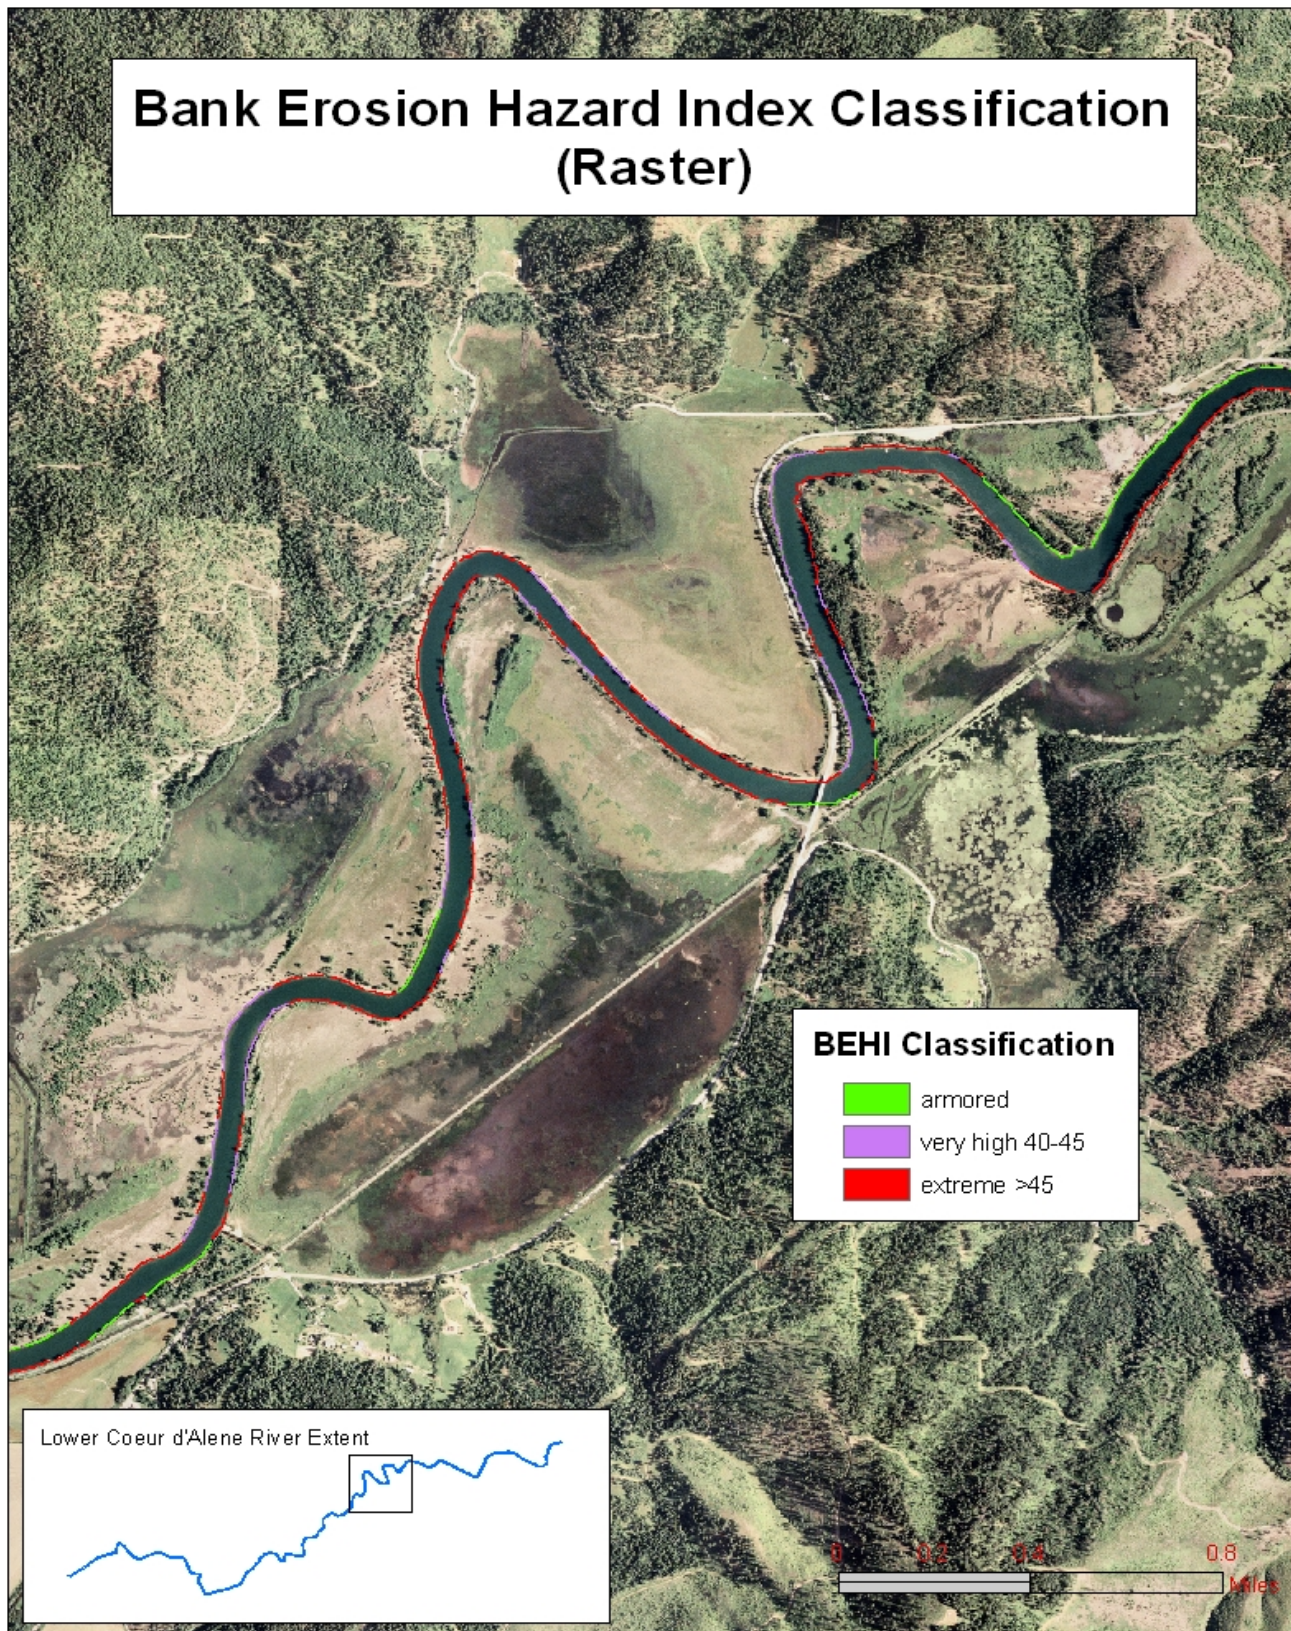
Figure 35. Bank Erosion Hazard Index classification

The BEHI raster to be used in the Prioritization Overlay was created from the line feature by assigning a raster value to segments of a line feature according to BEHI score (Table 8). Bank type 5 and 6 were given a value 5 (Very High) and types 1, 2, 3, and 4 were given the value 6 (Extreme). The armored banks were given a value of 0 and a score of NA (not applicable). The armored banks were excluded from the assessment and the overlay prioritization. A visual display is provided in Figure 34 and 35. A rating distribution graph visually displays the comparison among the raster values within the entire extent. The y value is the raster cell count. The tick marks are every one thousand cells.)

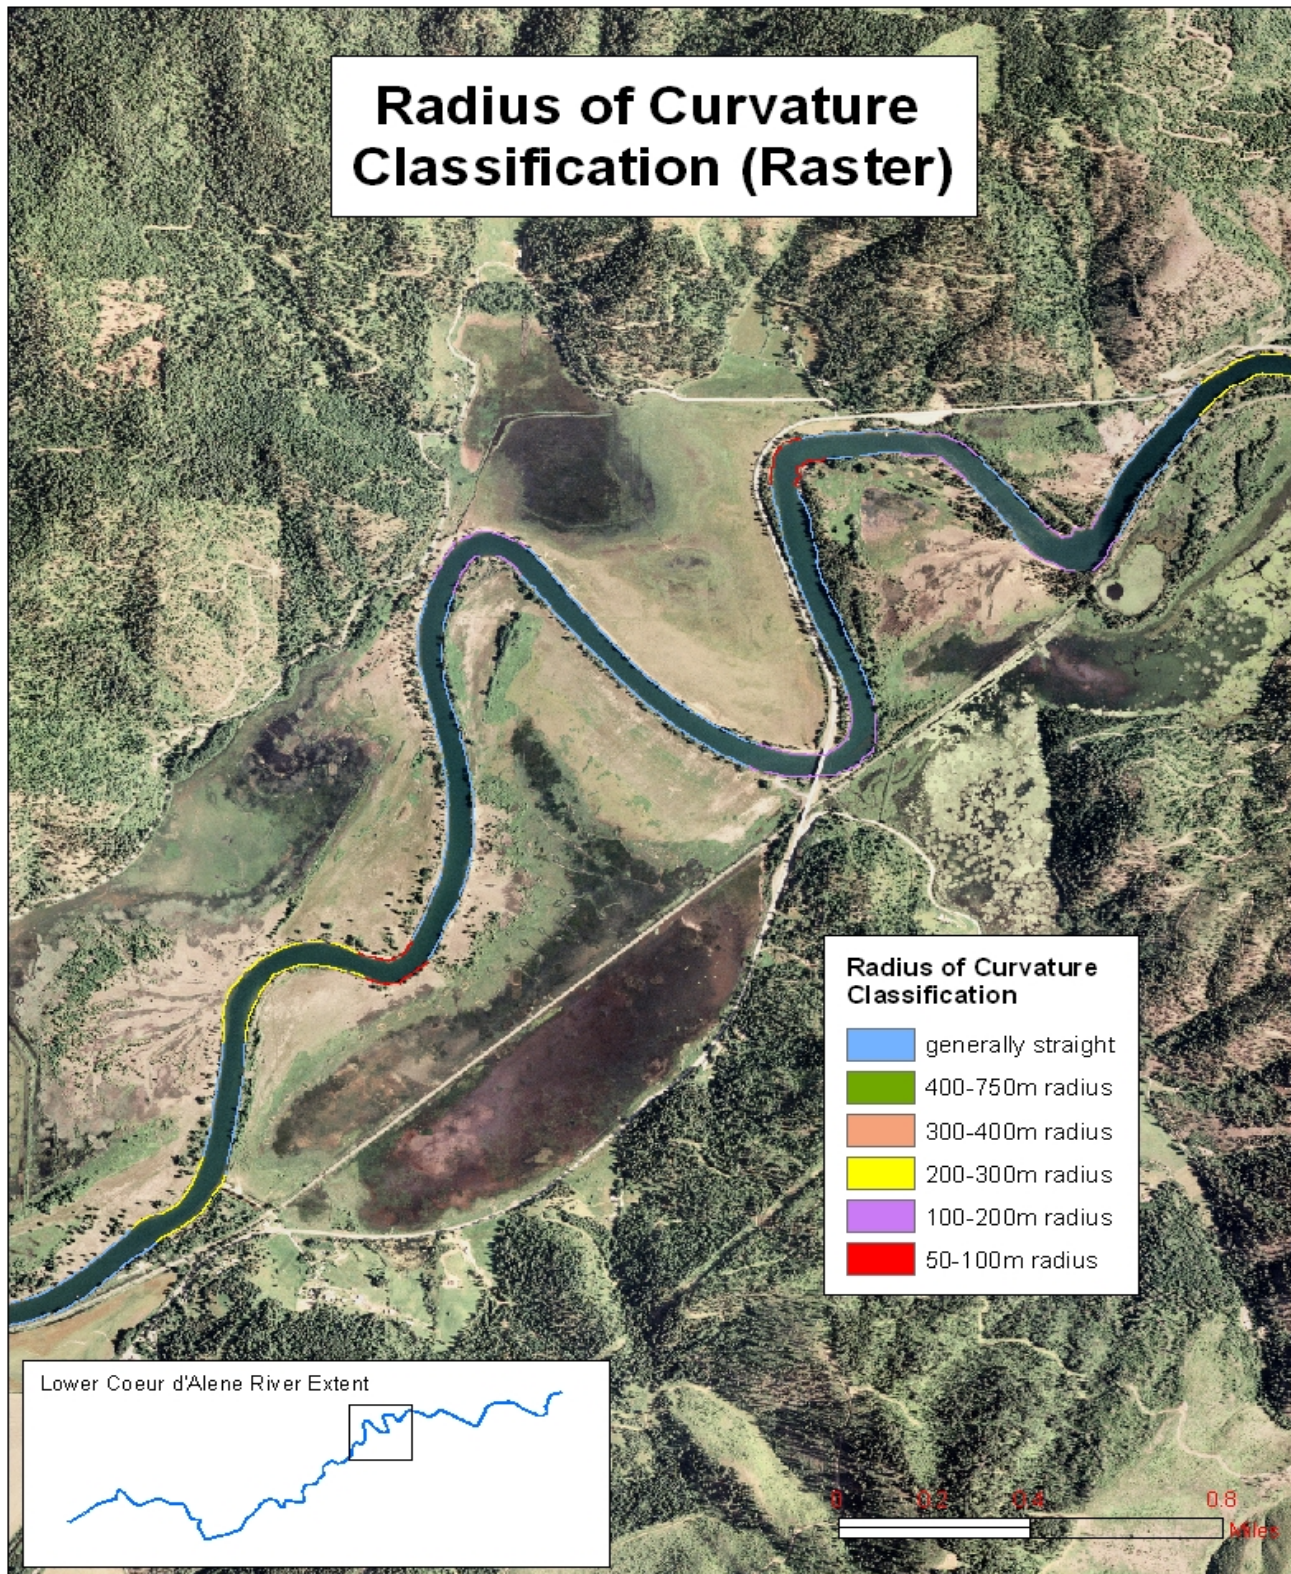
Figure 37. Radius of Curvature Classification (Raster)

Because shear stress is applied both to the inside and outside banks of a meander on the Coeur d'Alene River, Rosgen's Near Bank Stress could not be used as a factor in the Prioritization Overlay. Therefore, shear stress on both the inside and outside meander was weighted equally in the Prioritization Overlay, and radius of curvature became the only factor used to account for shear stress on the banks. To determine the radius of curvature of the meanders of the river, the bank line feature was segmented to represent three features: 1) the bank of an inside meander, 2) the bank of an outside meander, and 3) the bank along a generally straight section of the river (Table 9). The corresponding radius for that meander was also transferred to this line feature. Five classes were defined according to the radius, along with the banks in the generally straight sections of the river. The line feature was then converted to a raster to be used in the Prioritization Overlay. A visual display is provided in Figure 36 and 37.

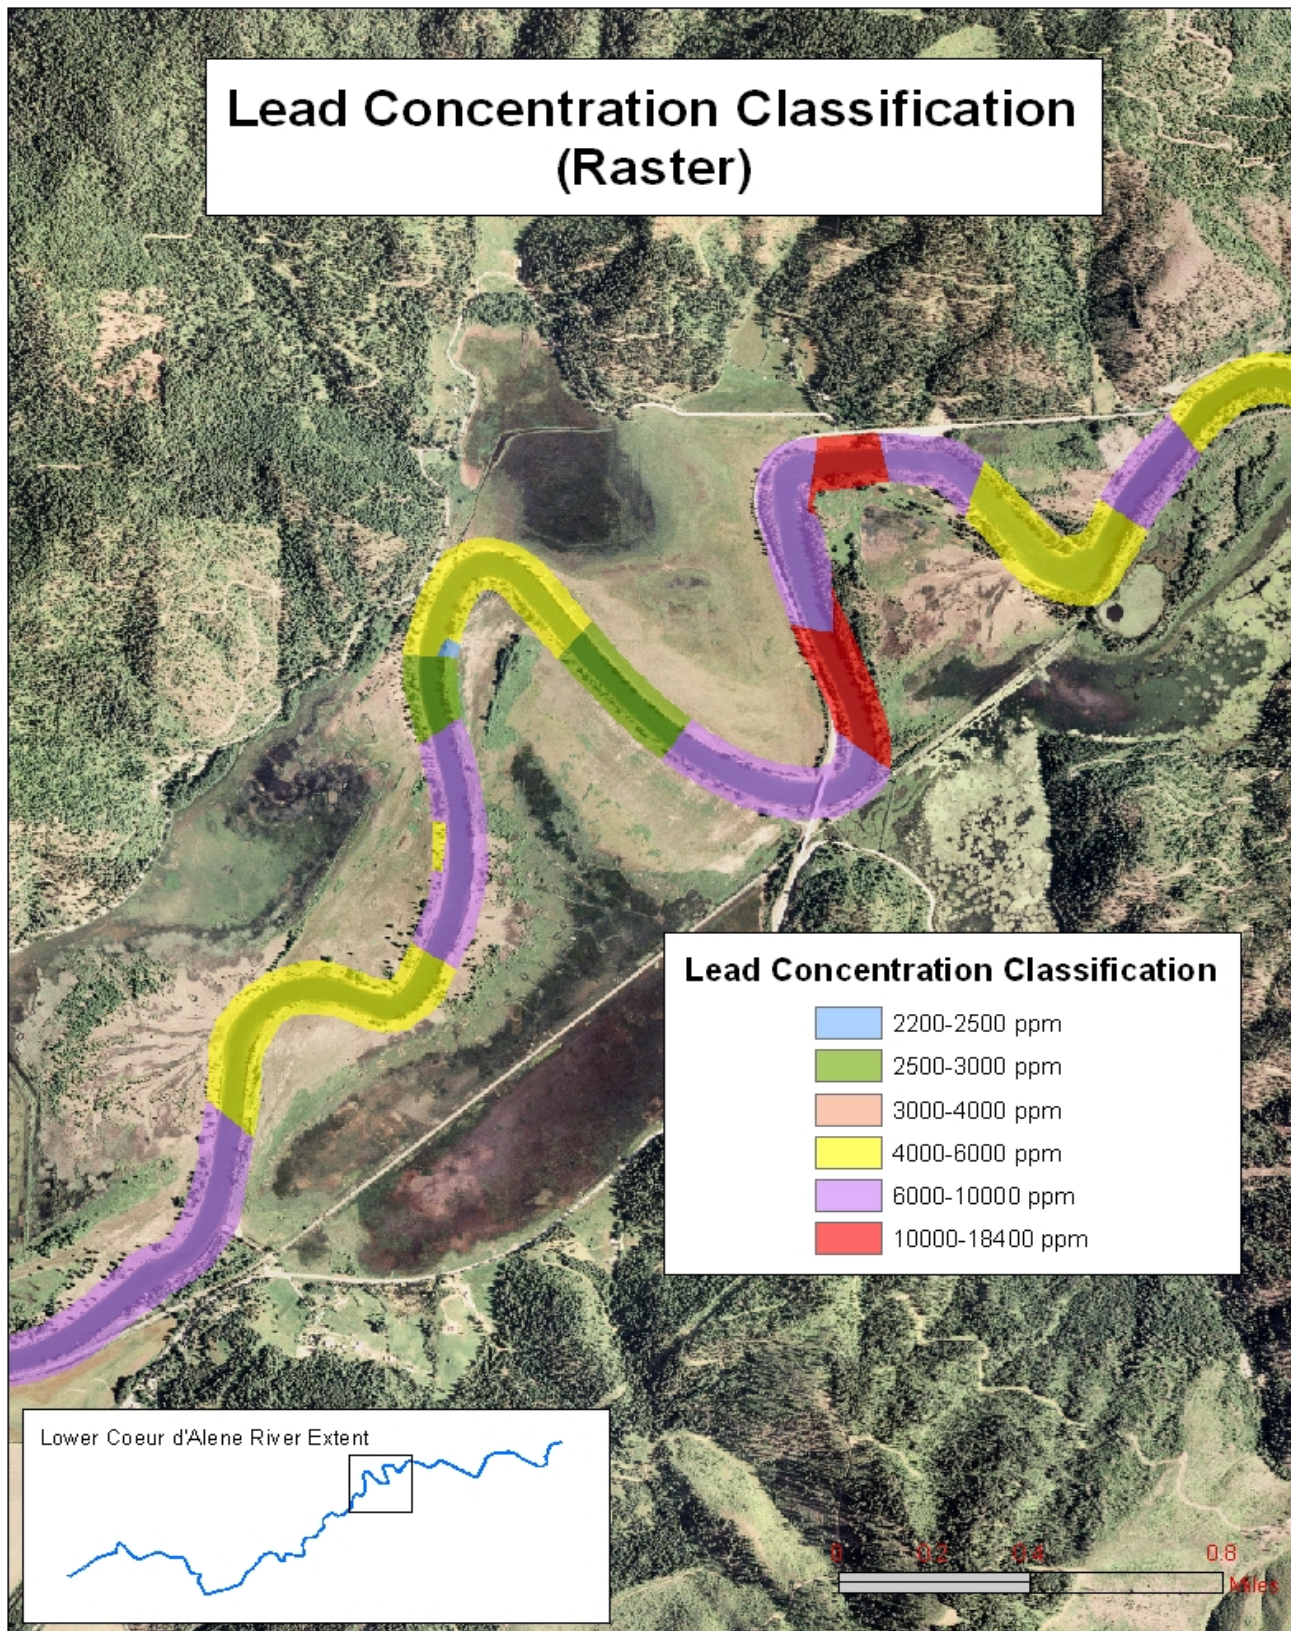
Figure 39. Lead concentration classification.

Eighty-two soil sample sites, thirty-four sampled in this study and forty-eight in the 2001 USGS study, were interpolated from control points along the riverbank to produce the lead concentration raster used in the Prioritization Overlay. The concentration is in parts per million (ppm). The interpolation was performed using ArcGIS to produce a Lead Concentration raster. This provides a depth-weighted average of the lead concentration of the banks within the study area (Table 10). A visual display is provided in Figure 38 and 39.

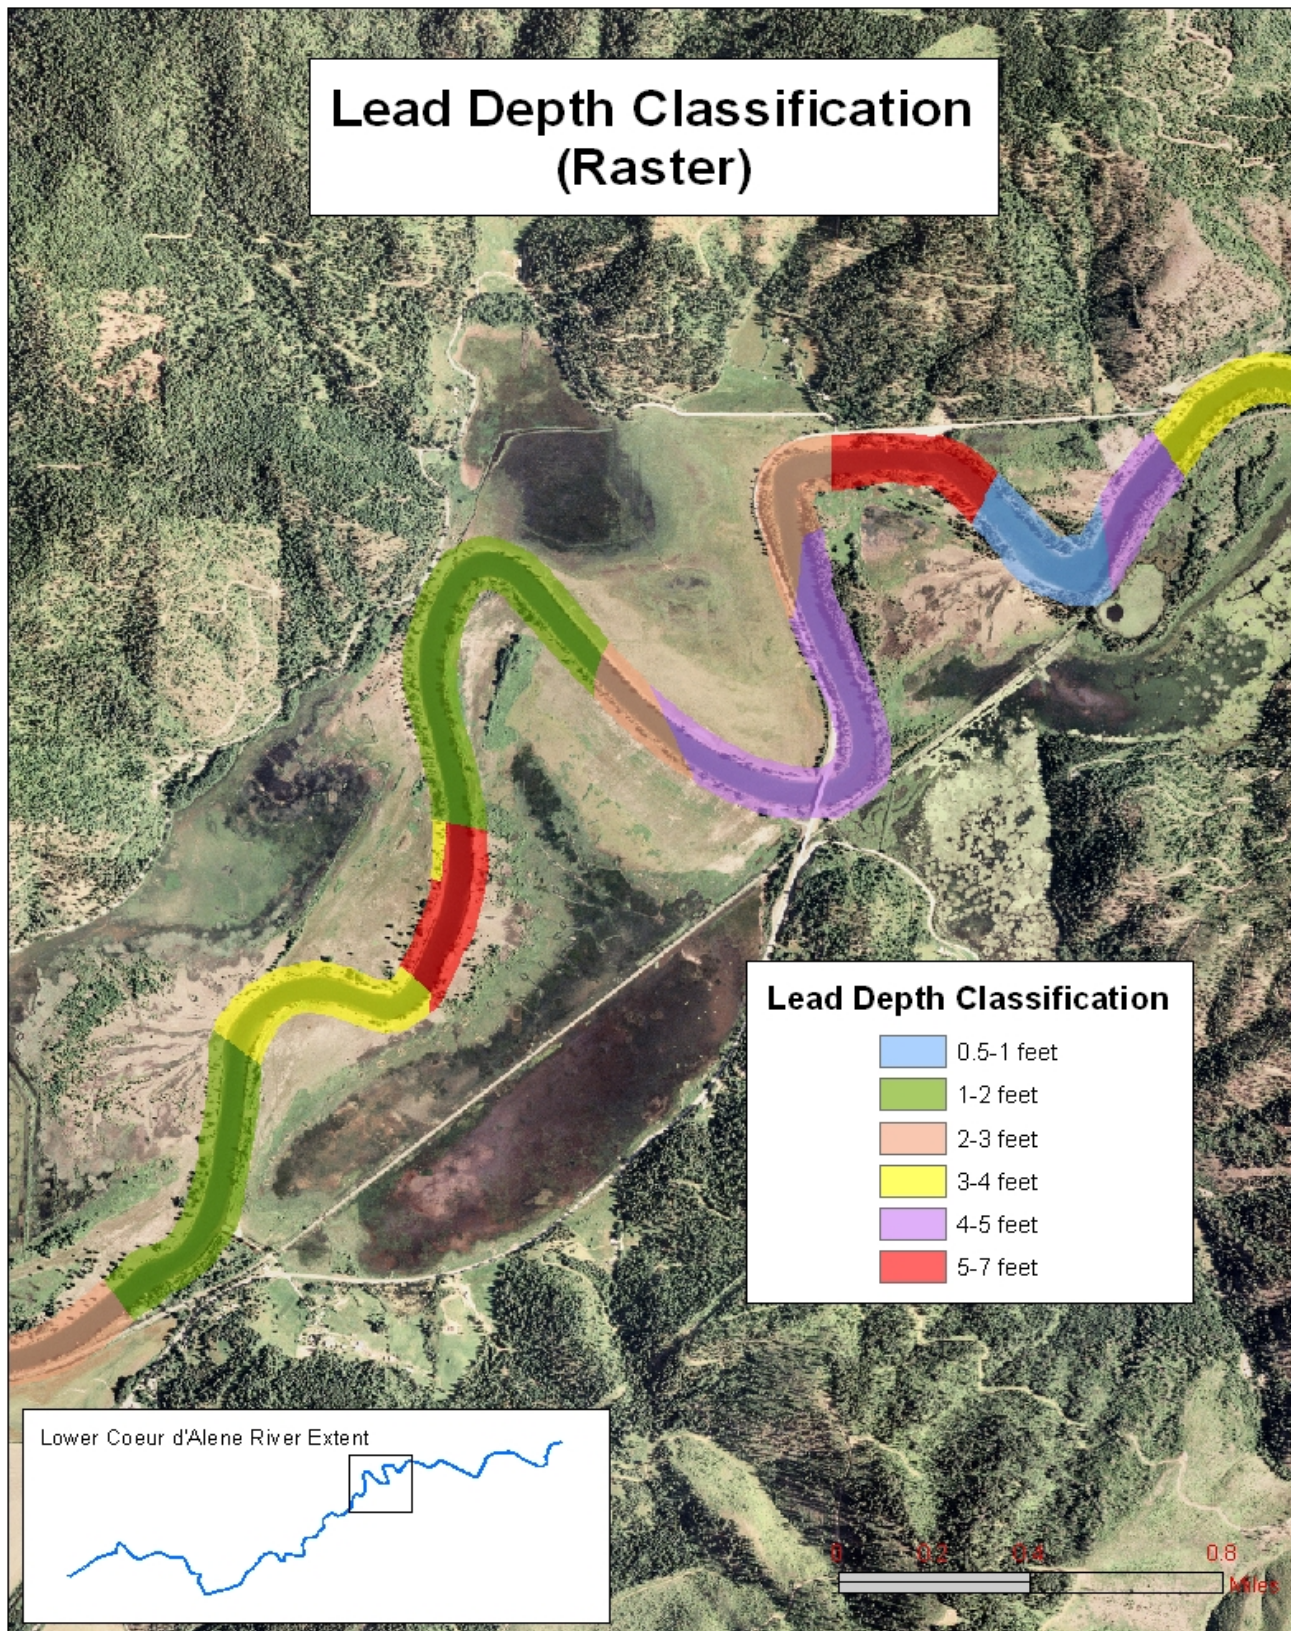
Figure 41. Lead depth classification.

Eighty-four soil sample sites, all from the 2001 USGS study, were interpolated along the riverbank to produce the lead depth raster used in the Prioritization Overlay. The depth was determined using a minimum threshold of one thousand ppm, which encompasses the sedimentation related to upstream mining activity. The depth does not represent the bank height, rather the depth of the sediment with a lead concentration of one thousand ppm or higher. The interpolation was performed using ArcGIS, based on the eighty-four samples, to produce a Lead Depth raster. This provides a general surface distribution of the lead depth for the banks within the study area (Table 11). A visual display is provided in Figure 40 and 41.

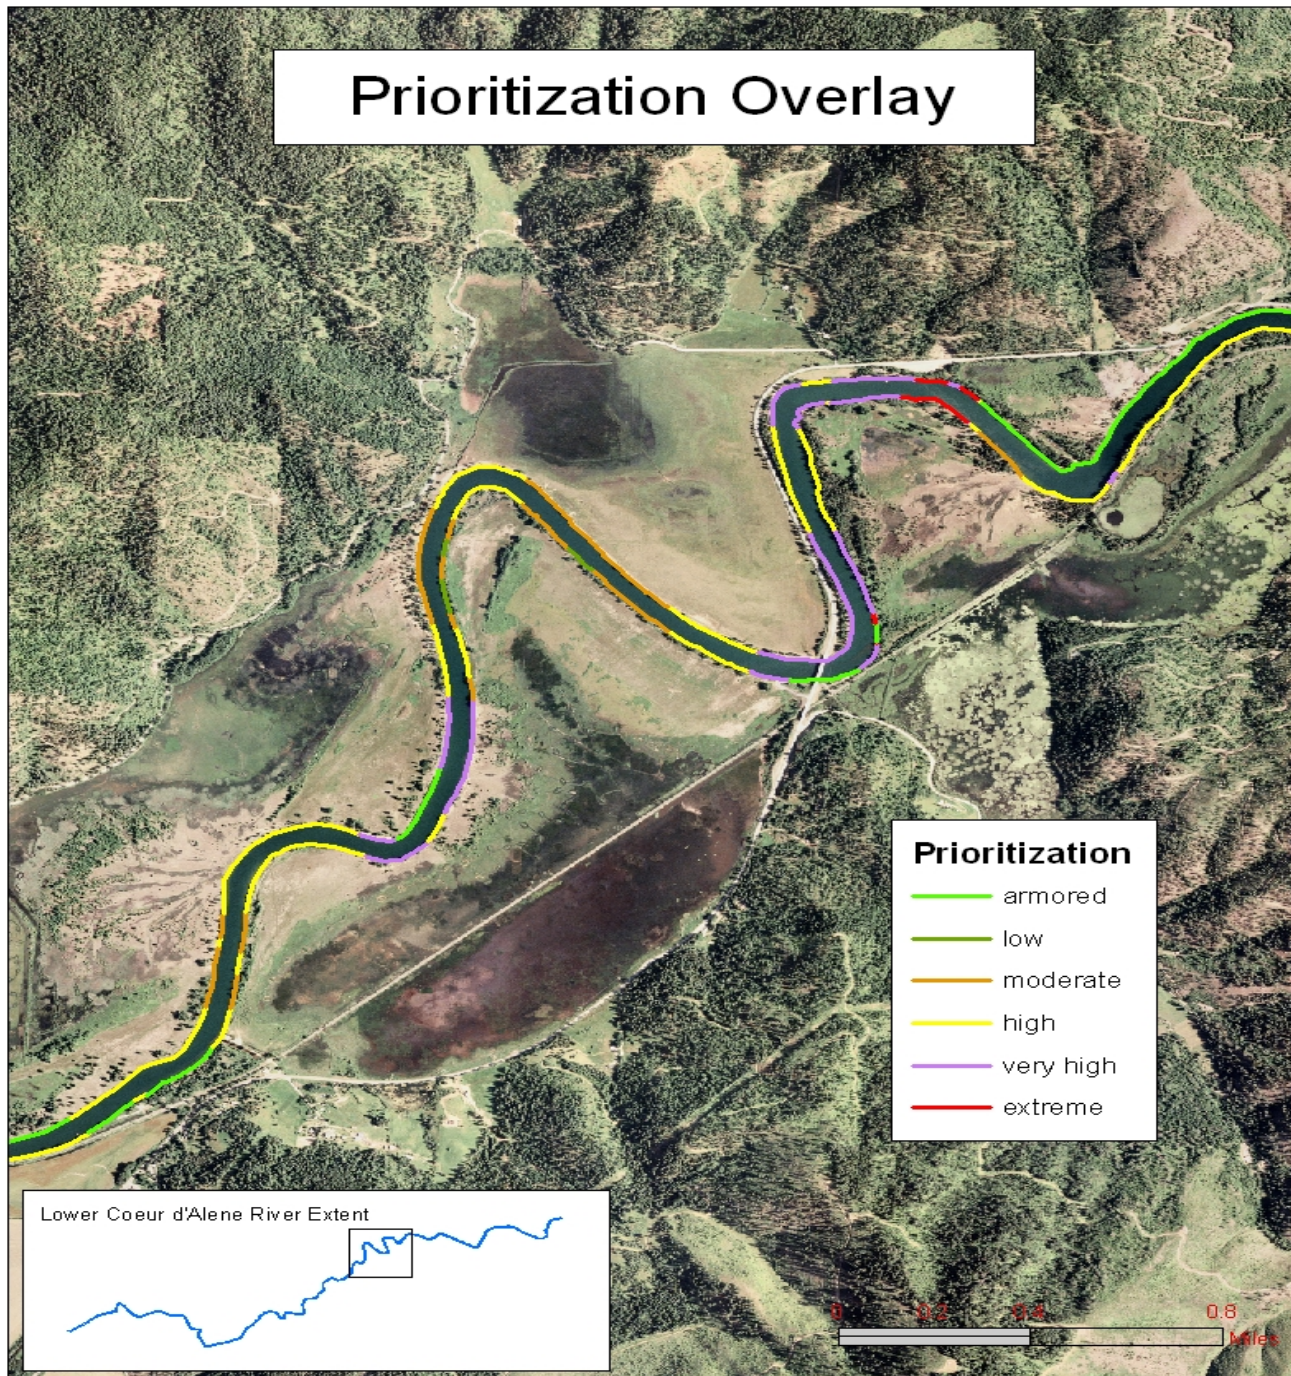
Figure 43. Prioritization Overlay for bank stabilization

The final product for the Prioritization Overlay was a line feature, representing the banks along the Lower Coeur d'Alene River, which was rated from very low to extreme (Figure 43). The armored banks were included but not rated. This data can be utilized as a guide in determining where stabilization efforts could be focused. This data is available in digital format or could be produced on a hardcopy map from a plotter. The process could be used in other scenarios or additional factors could be added.
